## INTERNAL EROSION AND FILTERS :

## UPDATE AND NEW TECHNICAL BULLETINS

MADRID 16 04 10

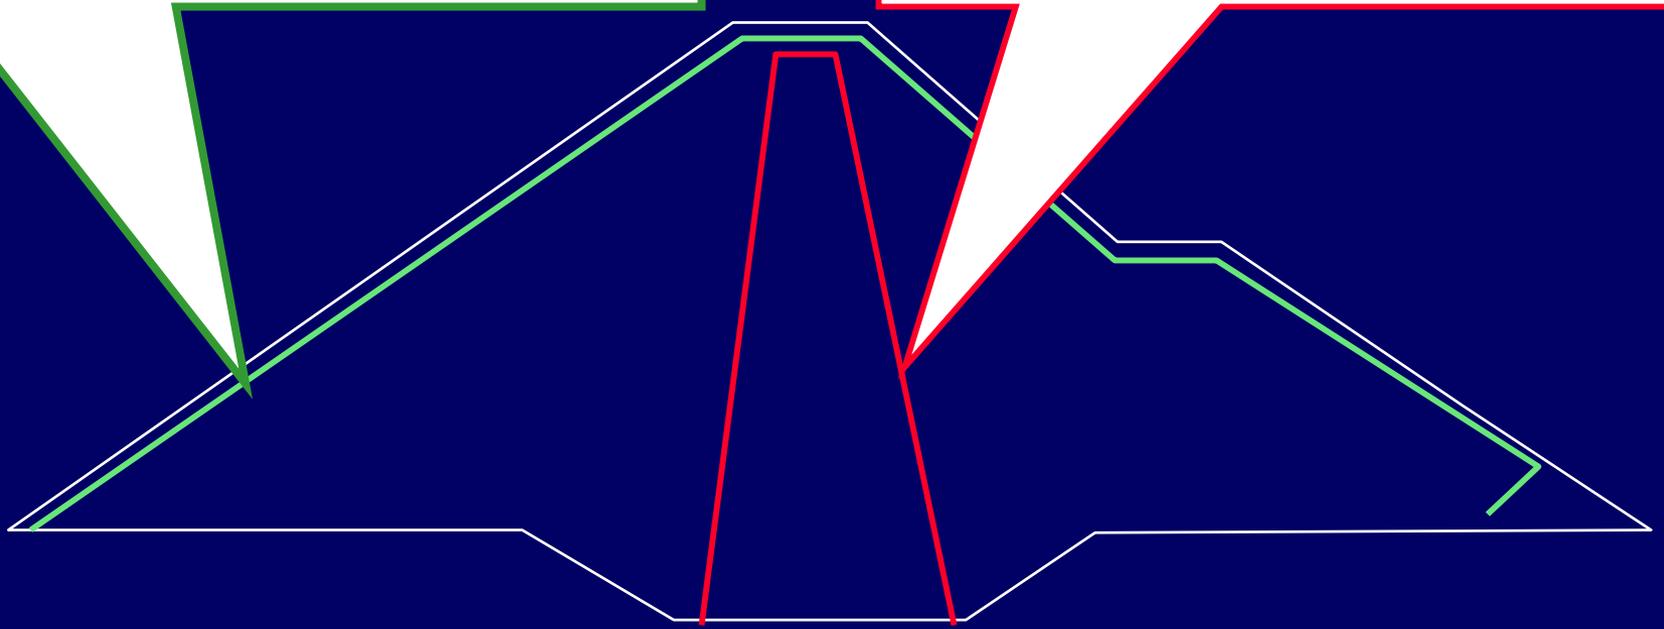
# Two kinds of filter destination

- low retention requirement
- High pore pressure requirement

- High retention requirement
- Low pore pressure requirement

**Critical Filter** : with large concern on dam safety  
**No critical Filter** with low concern on dam safety

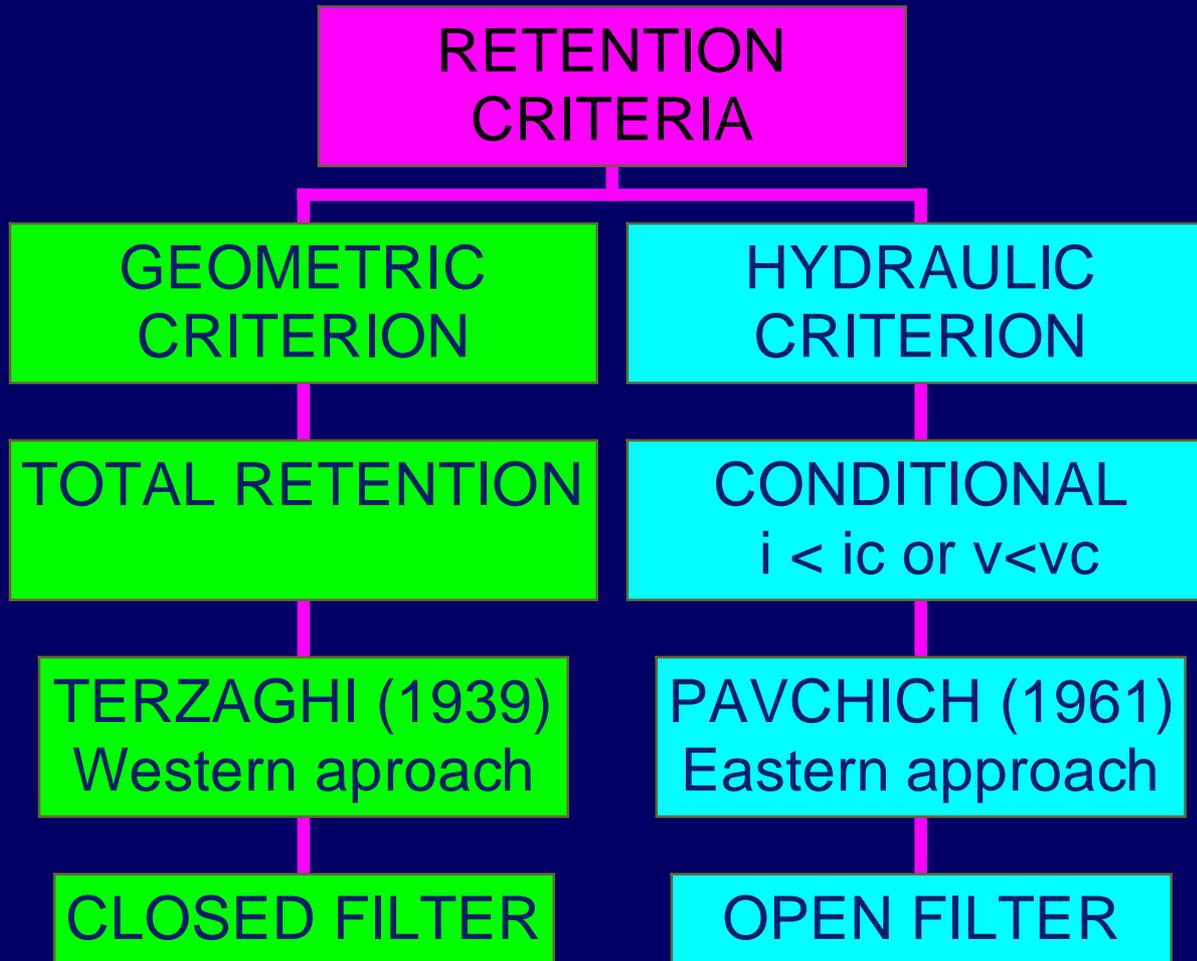
# Two kinds of Retention Criteria

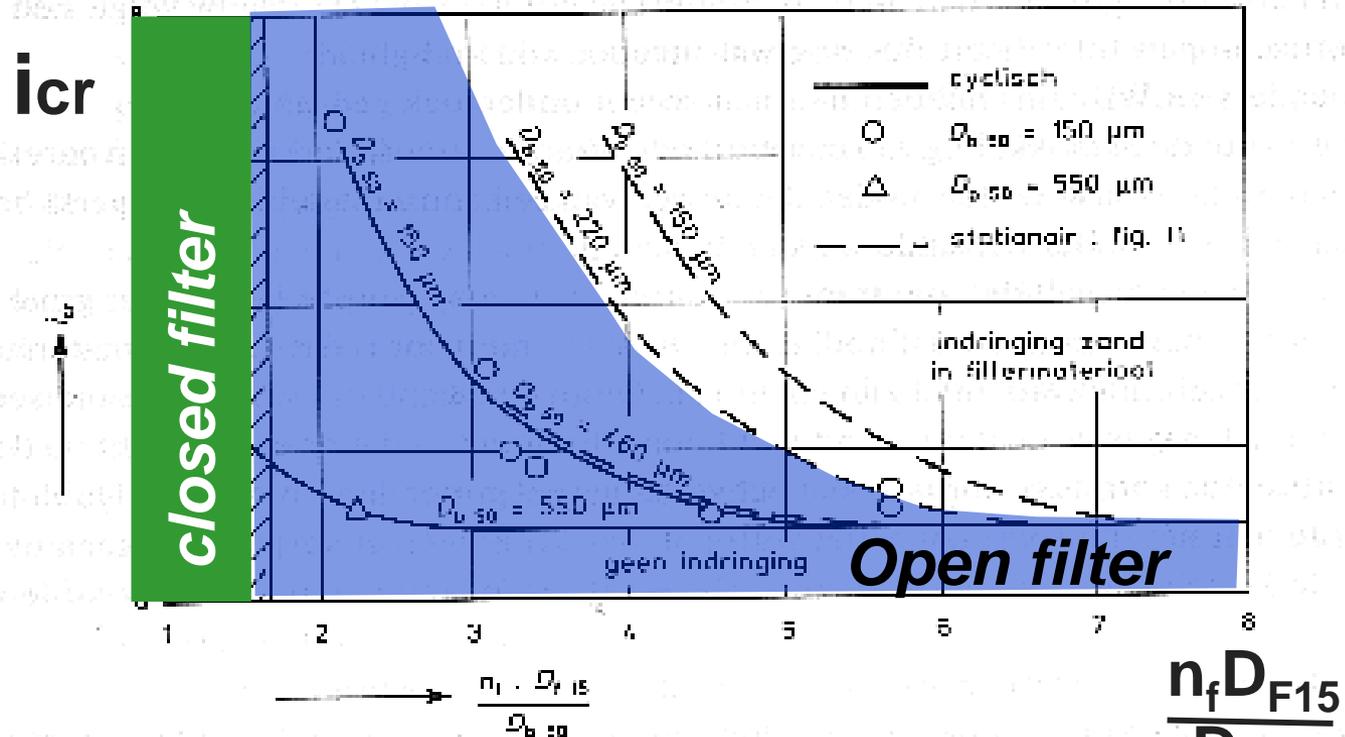
# Open Filters from Bakker K.J. and CUR (1994)

*Open filter : Retention depends on hydraulic gradient*

**Critical hydraulic Gradient Depends on the base soil gradation. Criterion linked to velocity and turbulence**

Flow perpendicular to interface

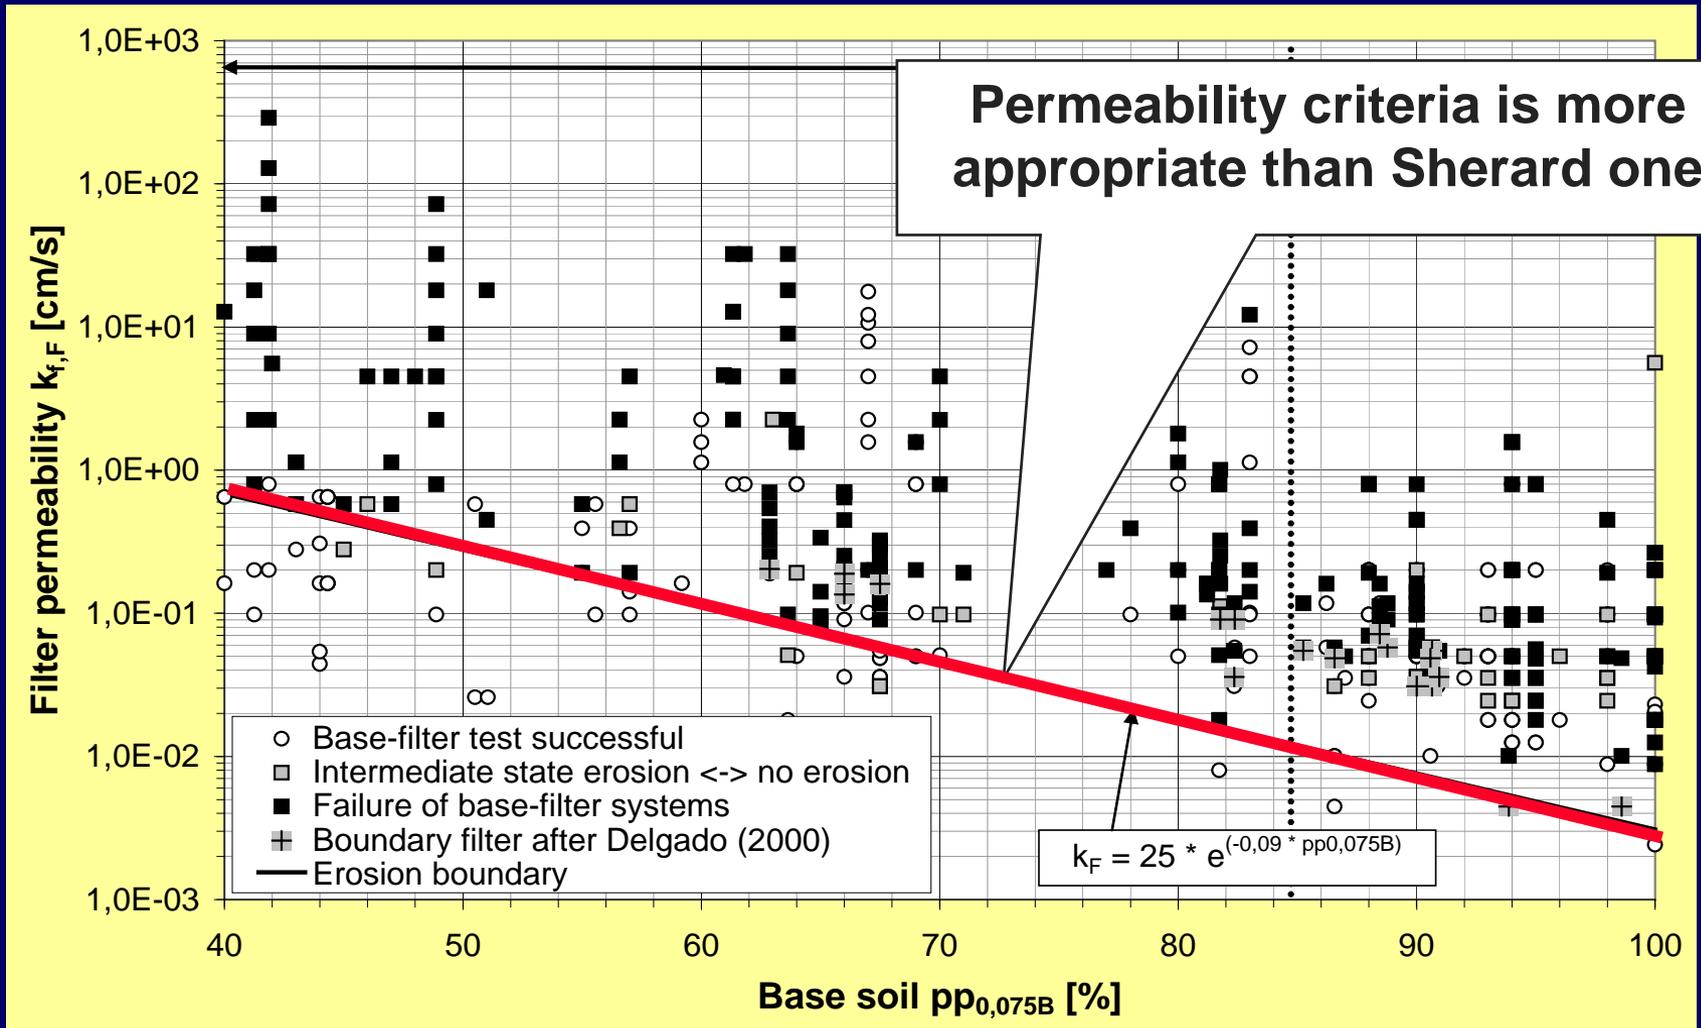
# New Retention criterion (Delgado)

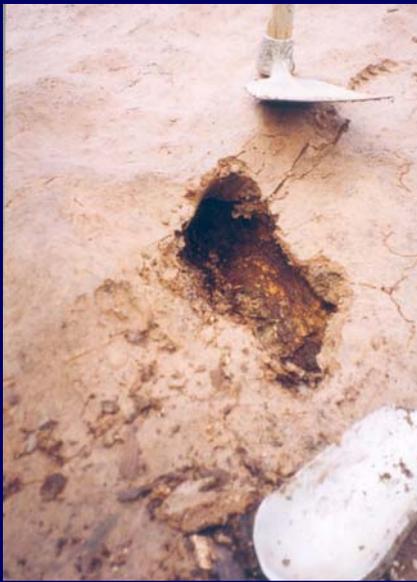
Torcy dam  
Root hole  
(Royet  
1997)

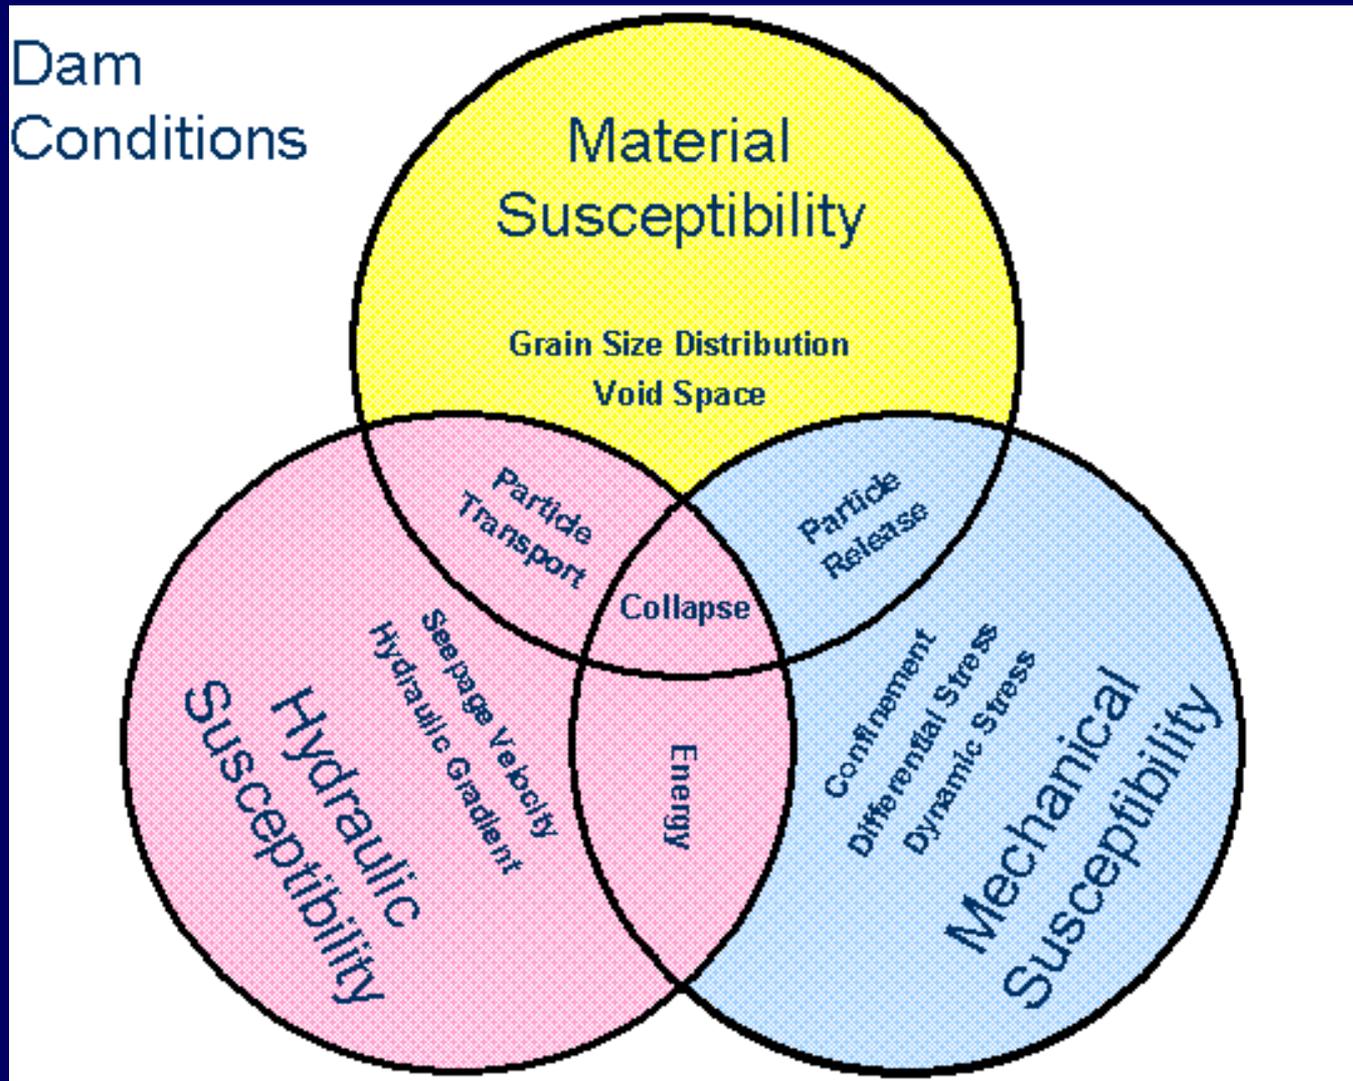
# Rapid screening assessment

The 3 dam conditions (S. Garner 2009)

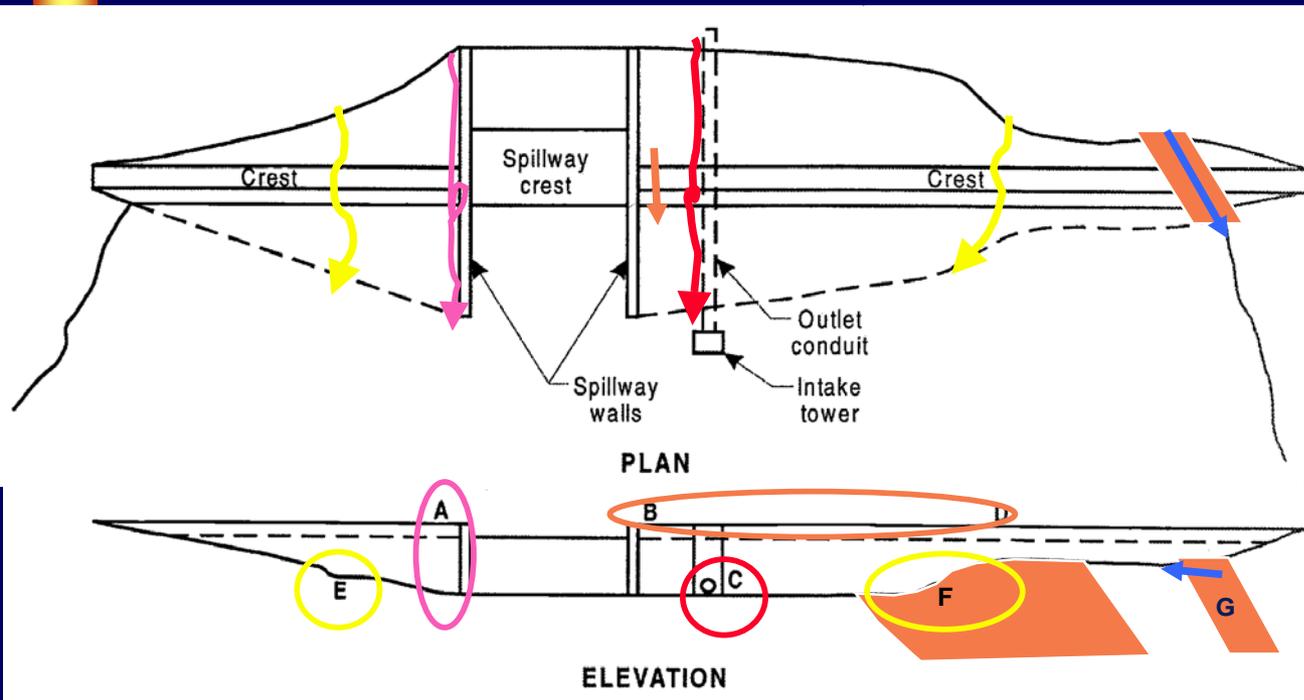
# Location of initiation : Where are the Failure paths?

- A, B Adjacent spillway walls.
- C Adjacent outlet conduit.
- D,E Related to irregularities in the foundation profile.
- F In the foundation
- G From embankment to foundation

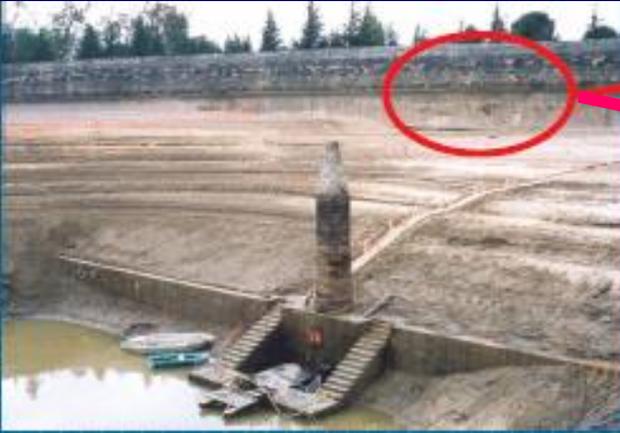
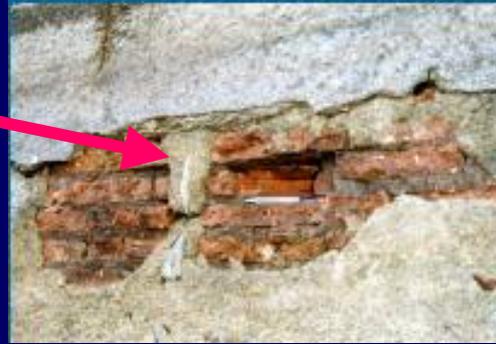
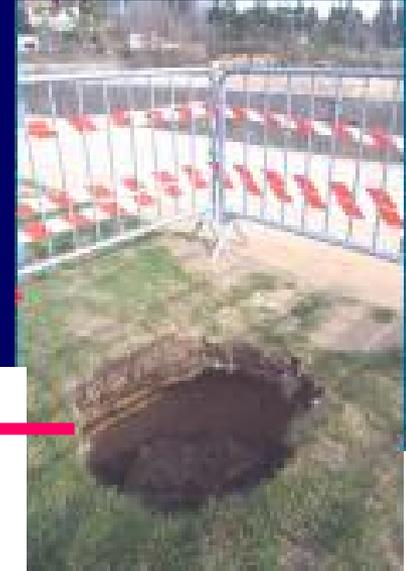
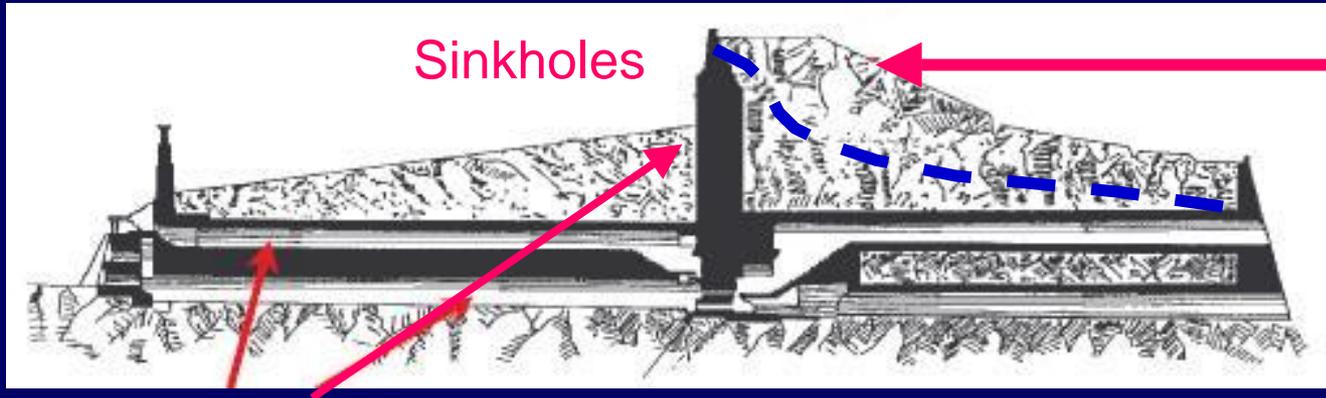
# St-Ferreol ageing (1675)

Leakage 6l/s, sinkholes and sand and gravel deposit in the conduit (some m<sup>3</sup>)

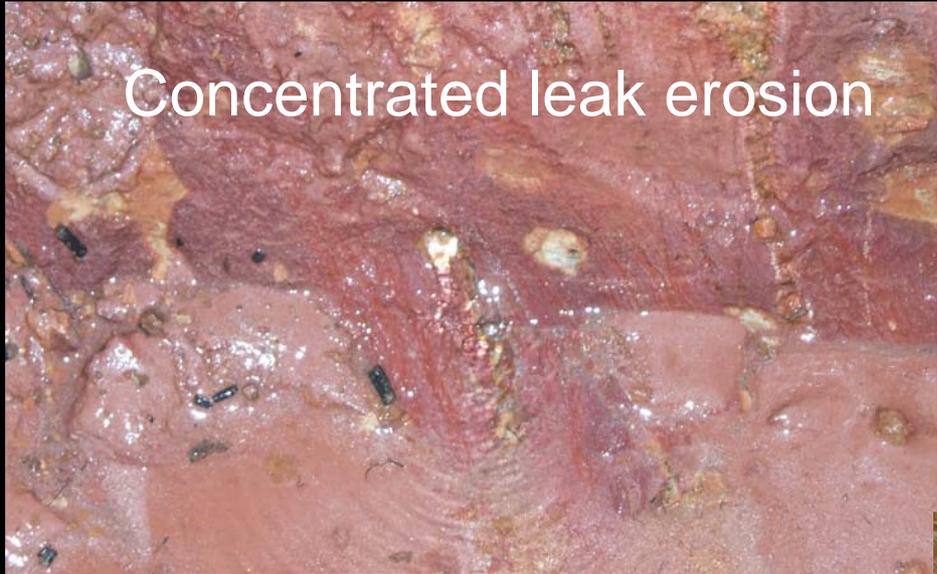
Concentrated leak erosion

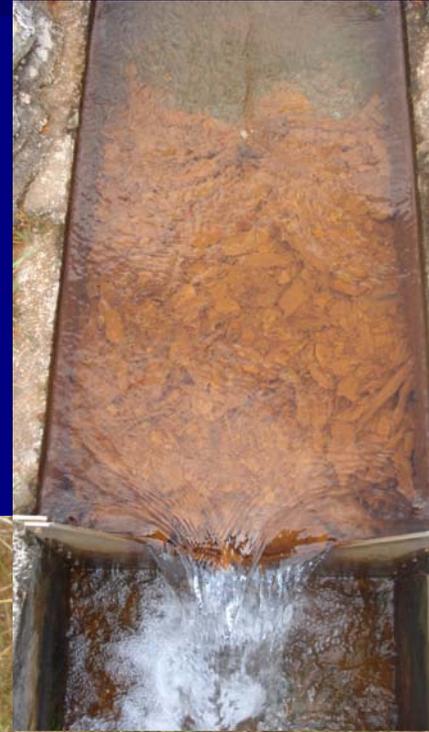
Large leakage with clay deposit in collector

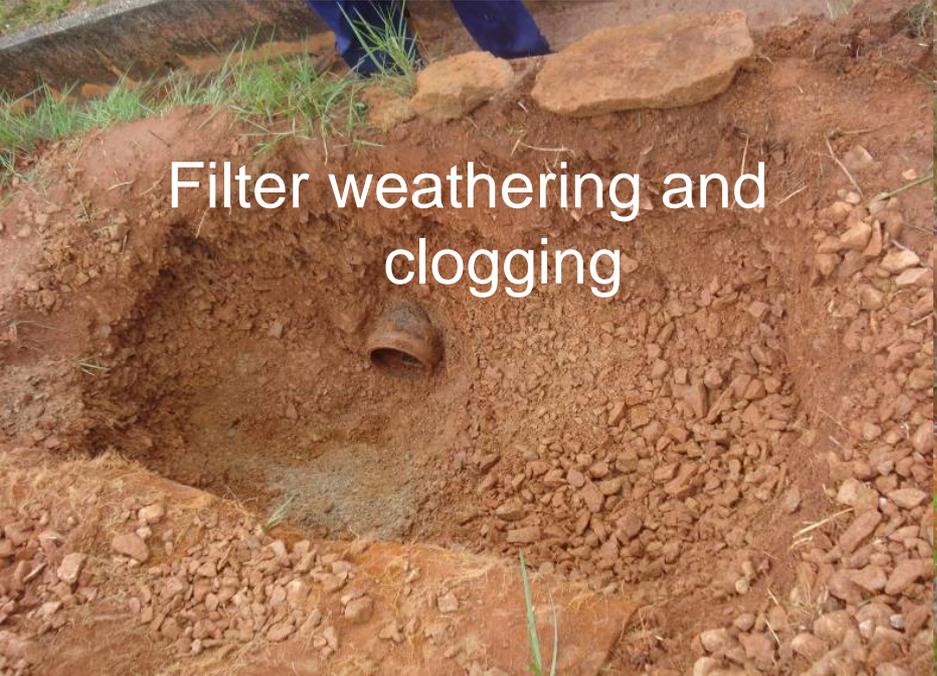
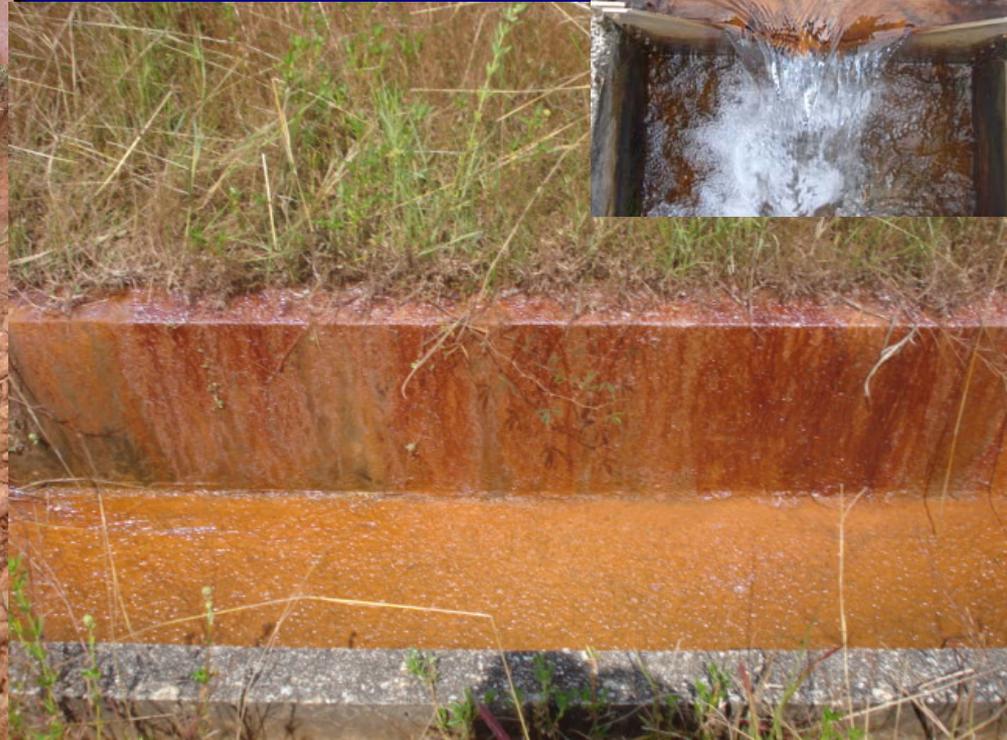
Filter weathering and clogging

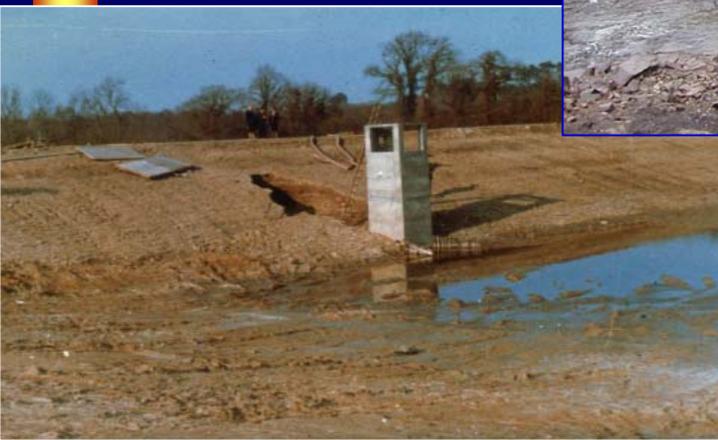
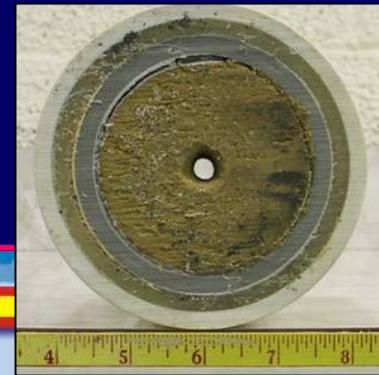
Test de HET  
(CEMAGREF  
LCPC)

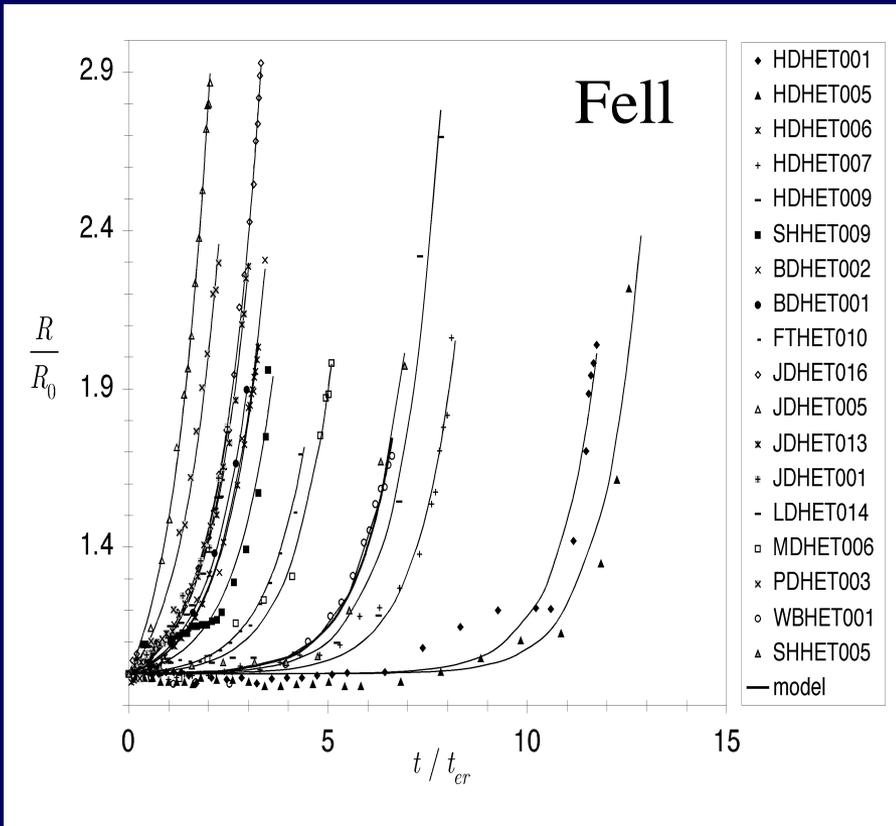
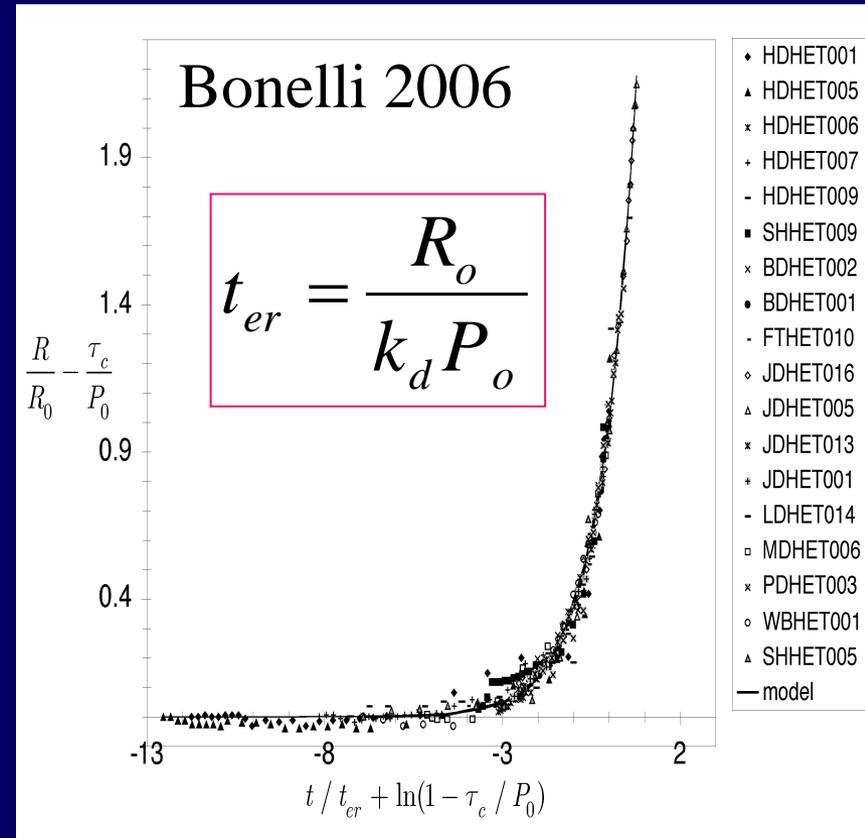
Only one relationship, but different time scales!

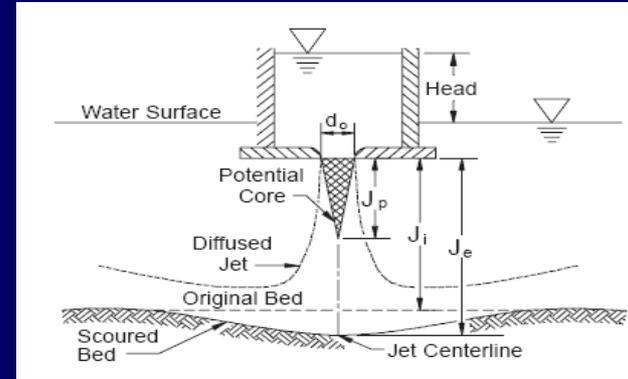
whether HET  
impossible

=> JET test

=>  $kd, \tau_c$

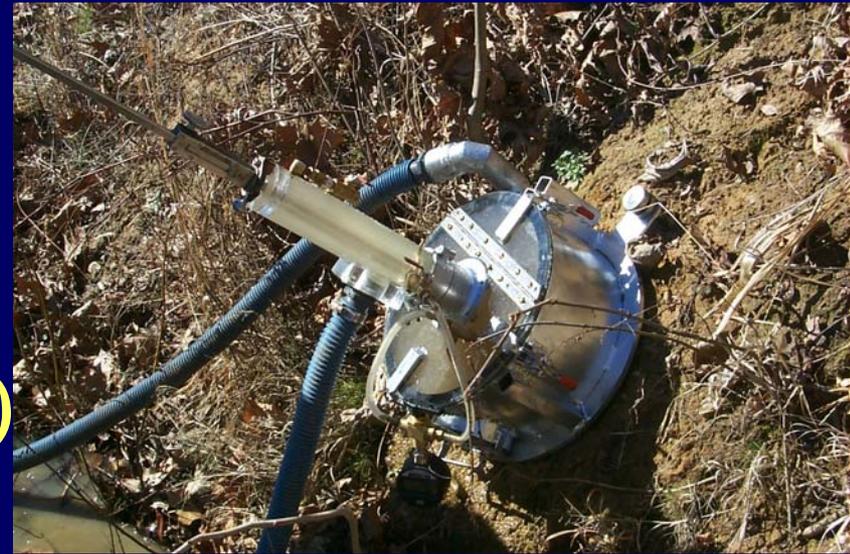
Dispersion  
(castle test)

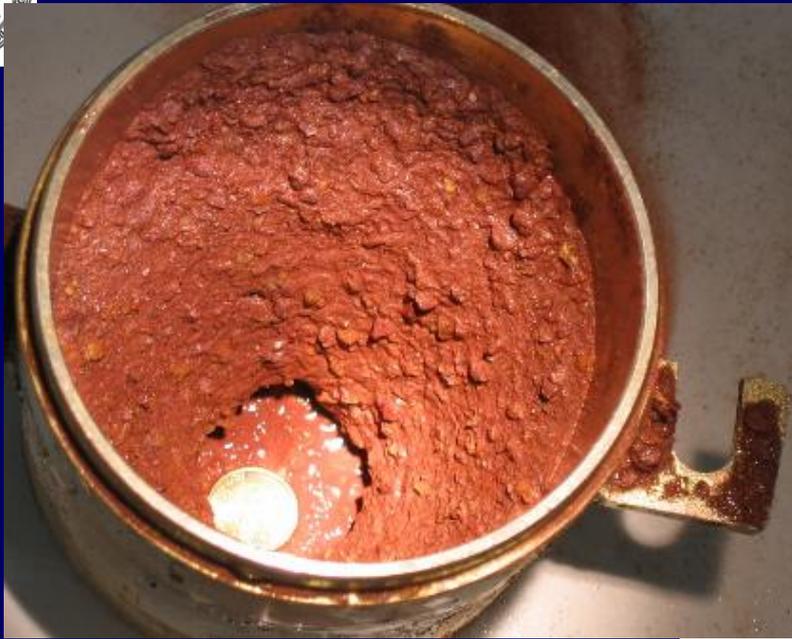
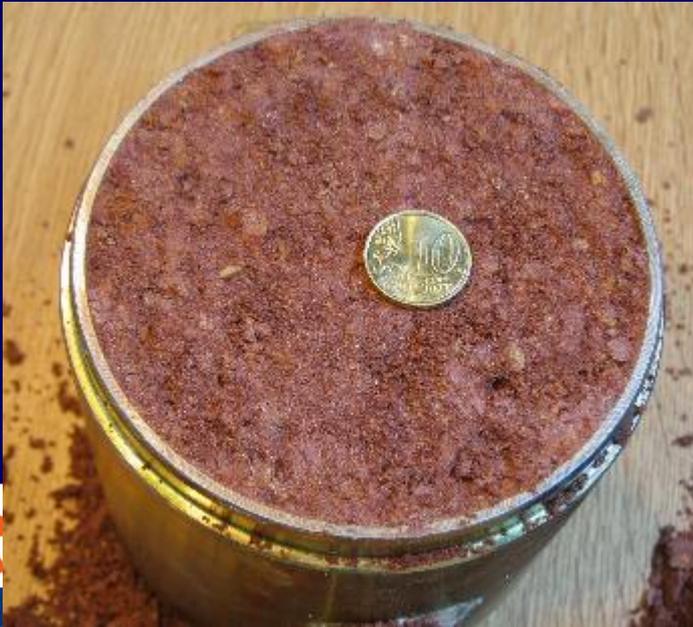
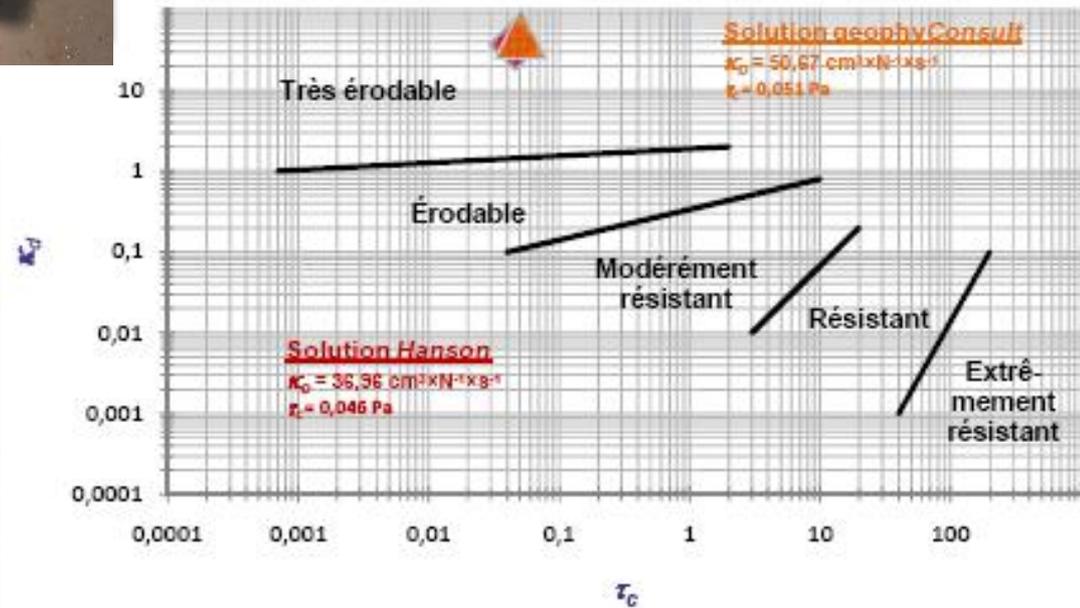
# Erosion test used as an Index test

JET test result on residual soil :

= Very large erodibility

=> **very urgent repair**

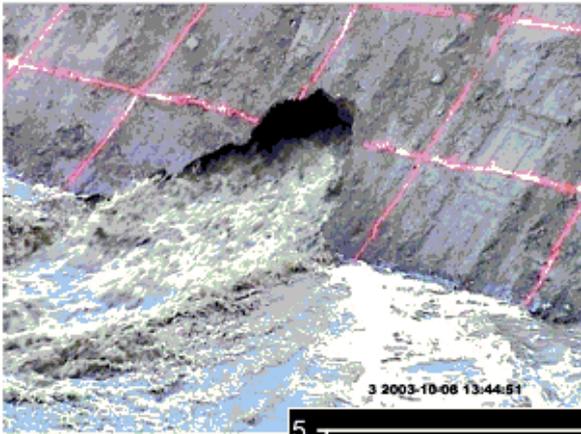
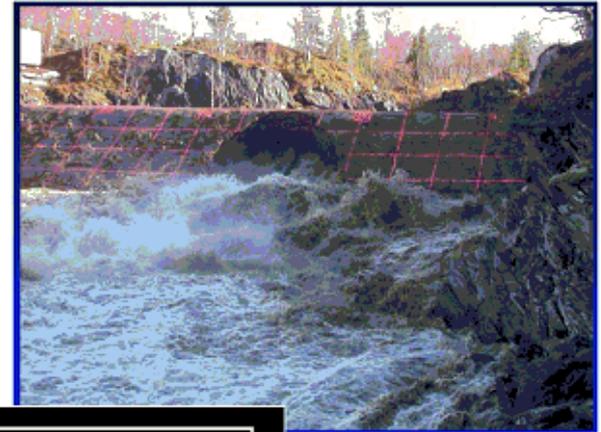
Norway  
*IMPACT*  
FP5 Project

Rossvatn  
field tests

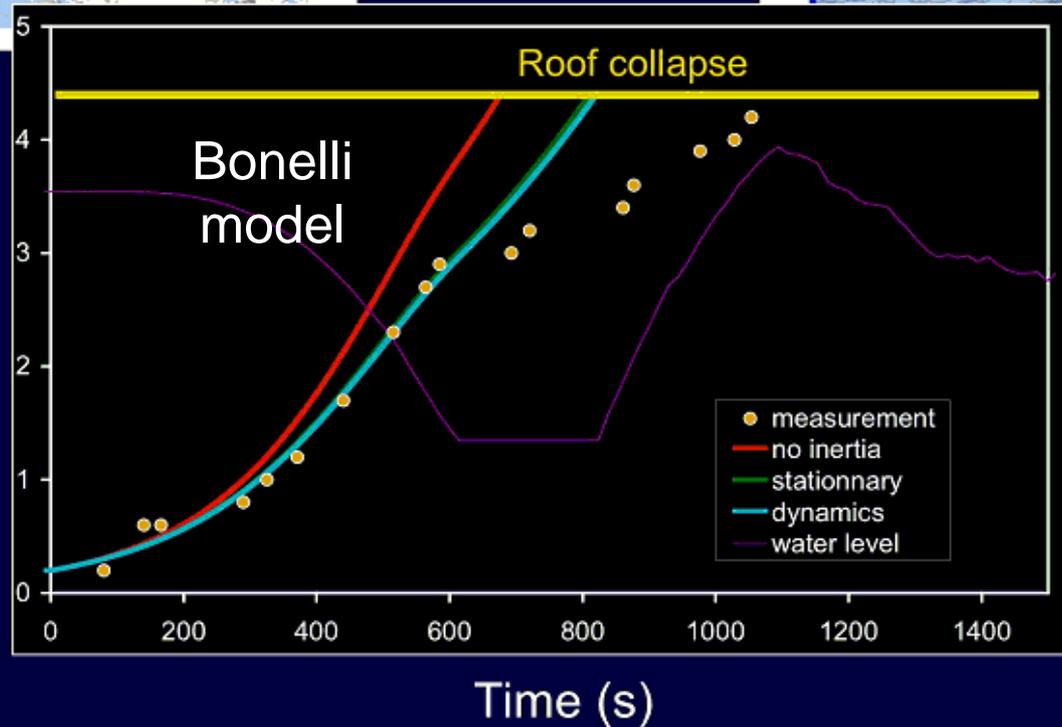
Radius (m)

$$\tau_c \approx 5 \text{ Pa}$$
$$k_{er} \approx 10^{-2} \text{ s/m}$$

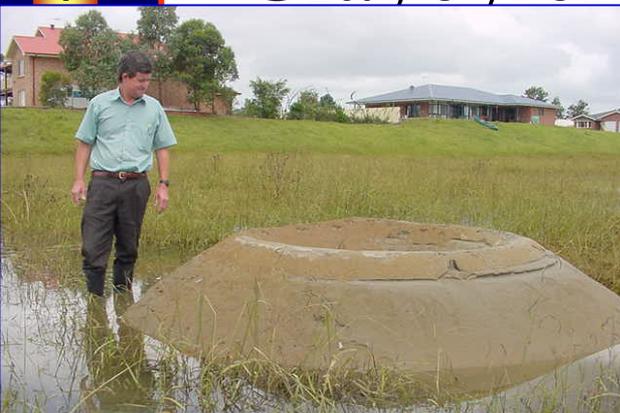
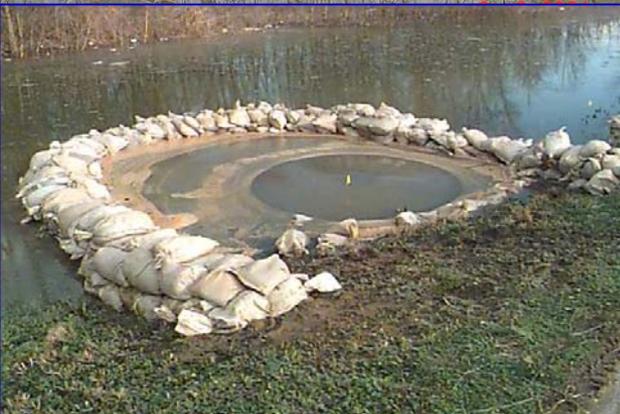
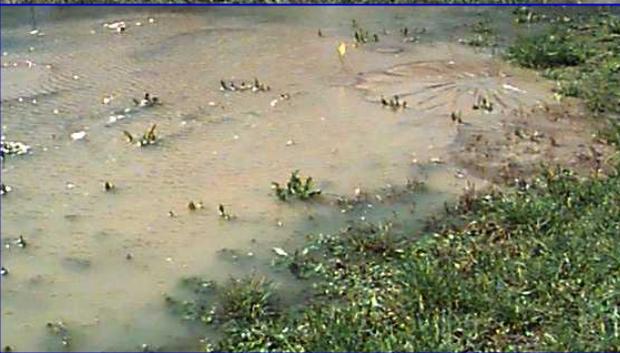
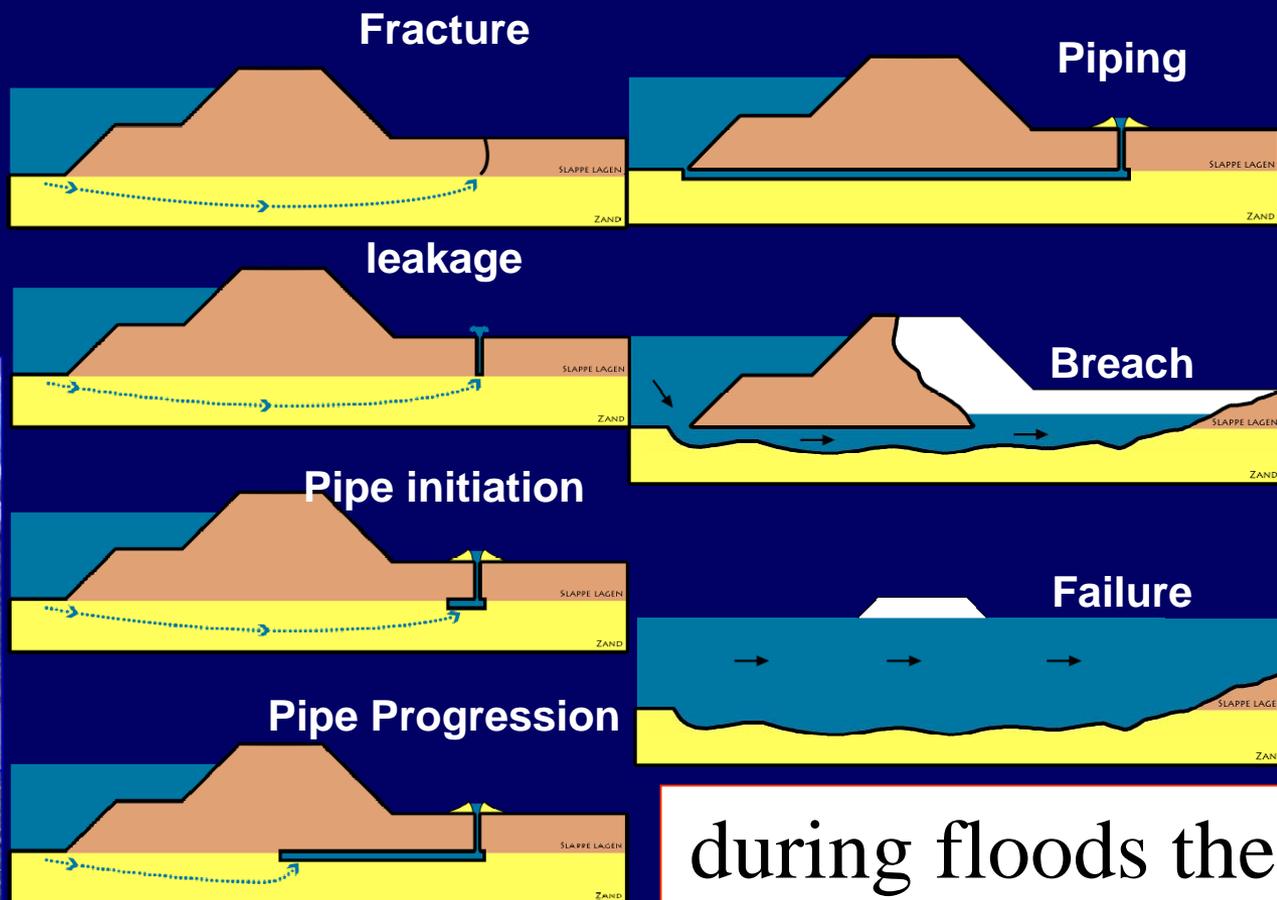
## Clayey embankment on sandy foundation

during floods the  
pipe increases  
up to failure

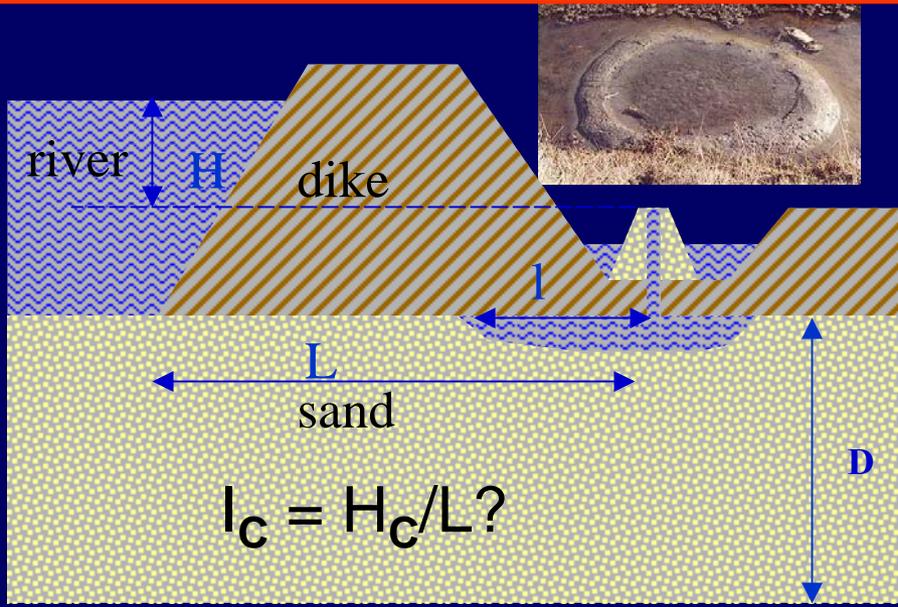
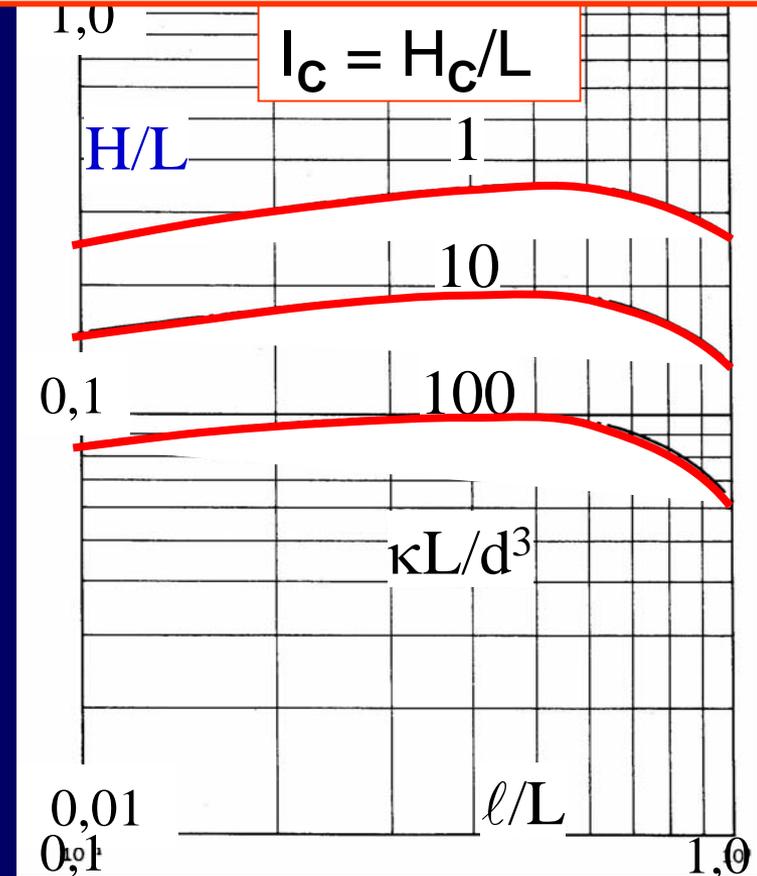
# 2 - Backward erosion

## Clayey embankment on sandy foundation

$$\Delta H_c = \alpha \cdot c \cdot \frac{\gamma_p}{\gamma_w} \tan(\theta) (0.68 - 0.10 \ln(c)) \cdot L$$

$$\alpha = \left( \frac{D}{L} \right)^{\left( \frac{0.28}{\left( \left( \frac{D}{L} \right)^{2.8} - 1 \right)} \right)}$$

$$c = \eta d_{70} \left( \frac{1}{\kappa L} \right)^{\frac{1}{3}}$$

Sellmeijer (1988)

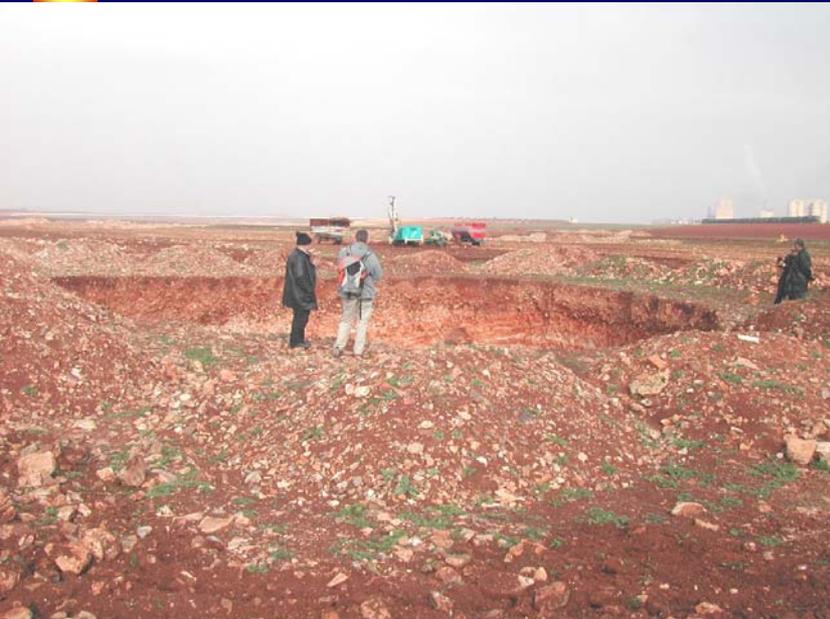
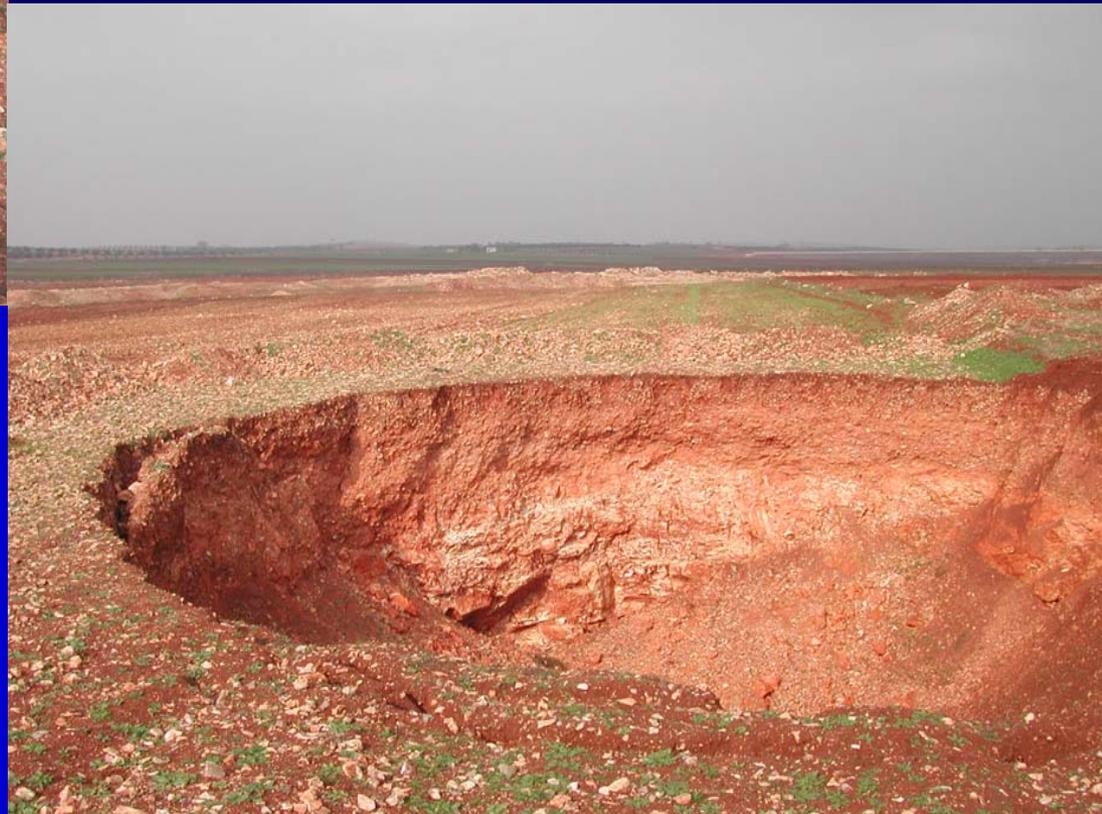
# 2 - Backward erosion in karstic foundation

El Gassanieh reservoir (2003)  
during an extreme flood

1m water load caused  
the collapse of 3  
sinkholes (15-25 m  
diameter) along a  
fault in the reservoir
