## INTERNAL EROSION AND FILTERS :

## UPDATE AND NEW TECHNICAL BULLETINS

MADRID 16 04 10

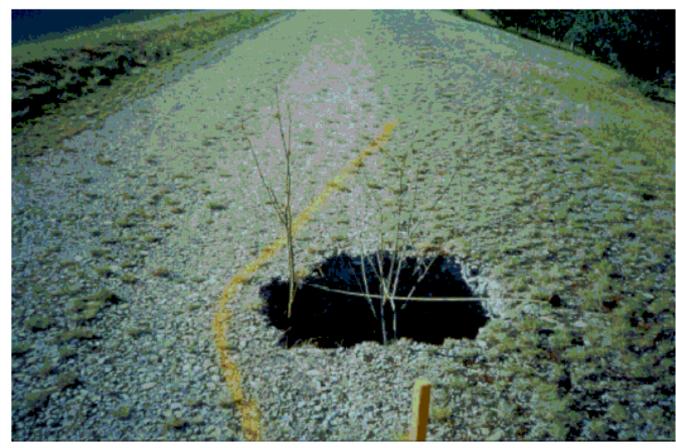
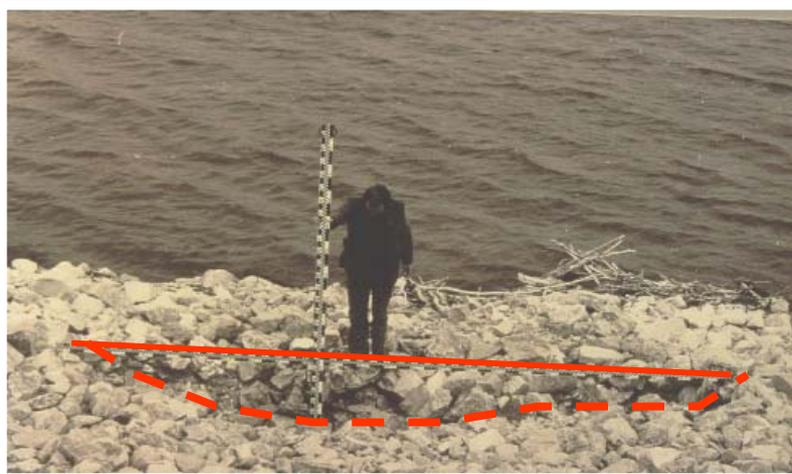
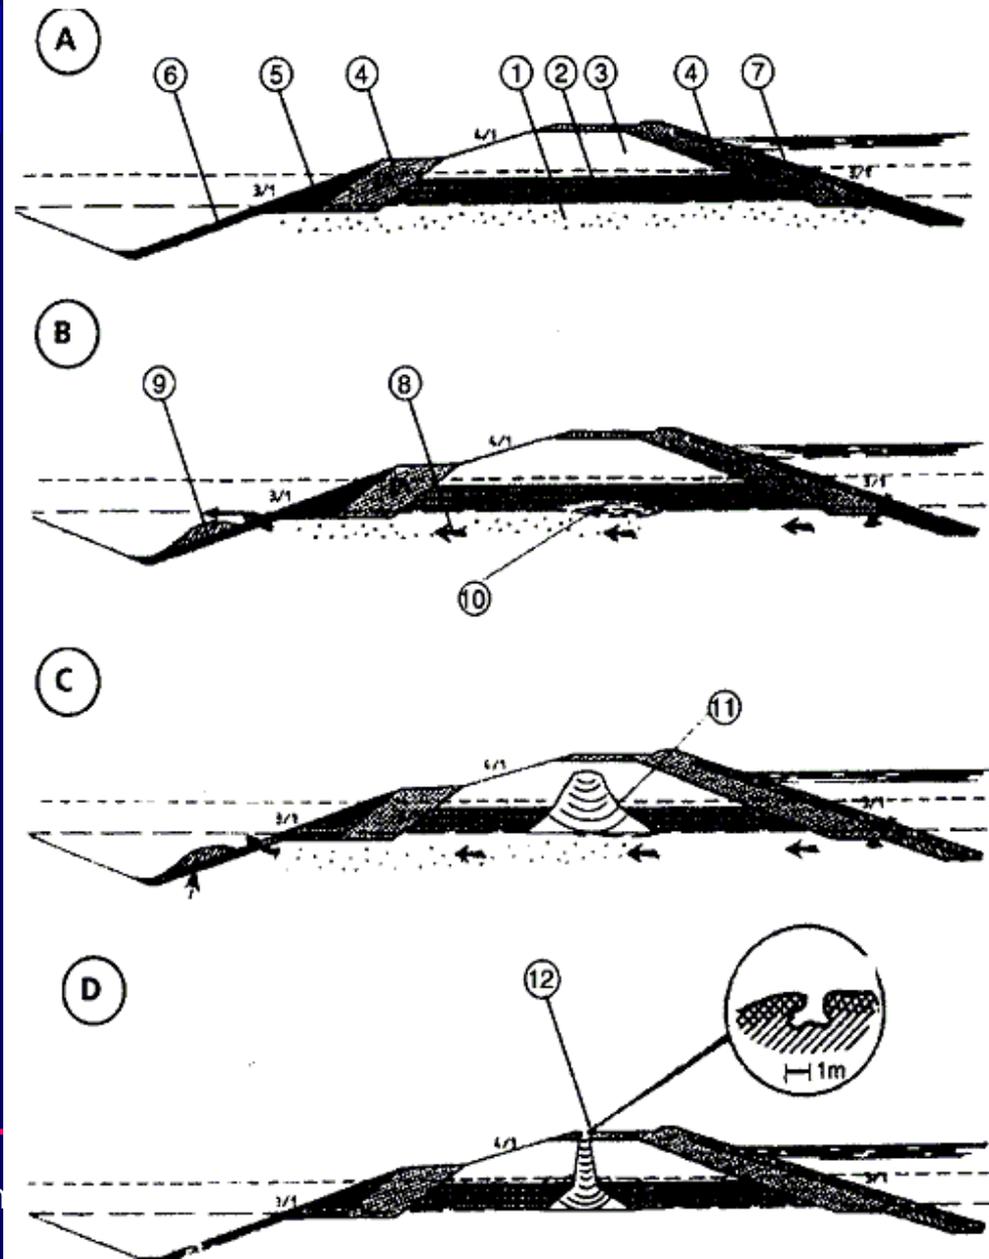
# Embankment on gravely alluvium

## 3 Contact erosion

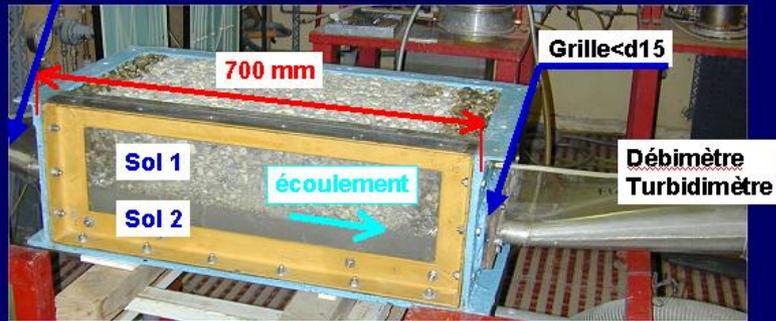
## 3 – Contact erosion

Alimentation par un réservoir à niveau constant avec mesure du débit

No erosion with  $v < \#1\text{cm/s}$

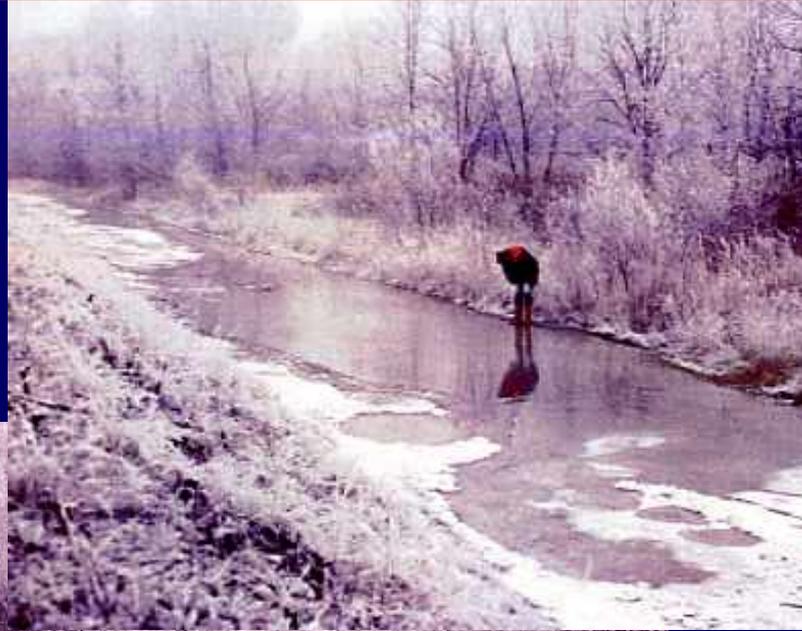
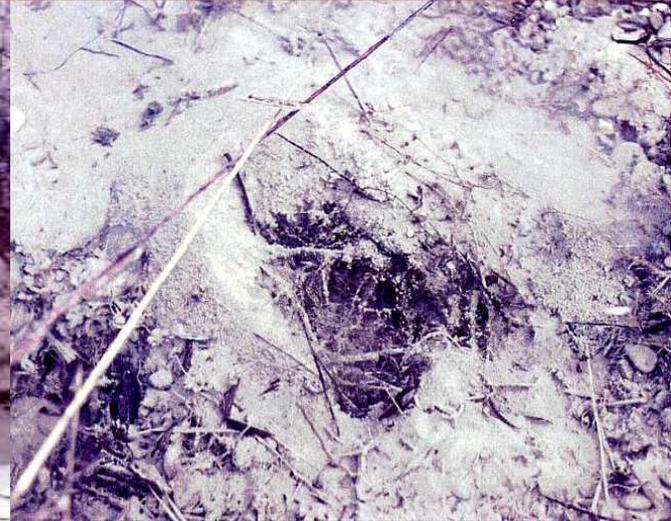
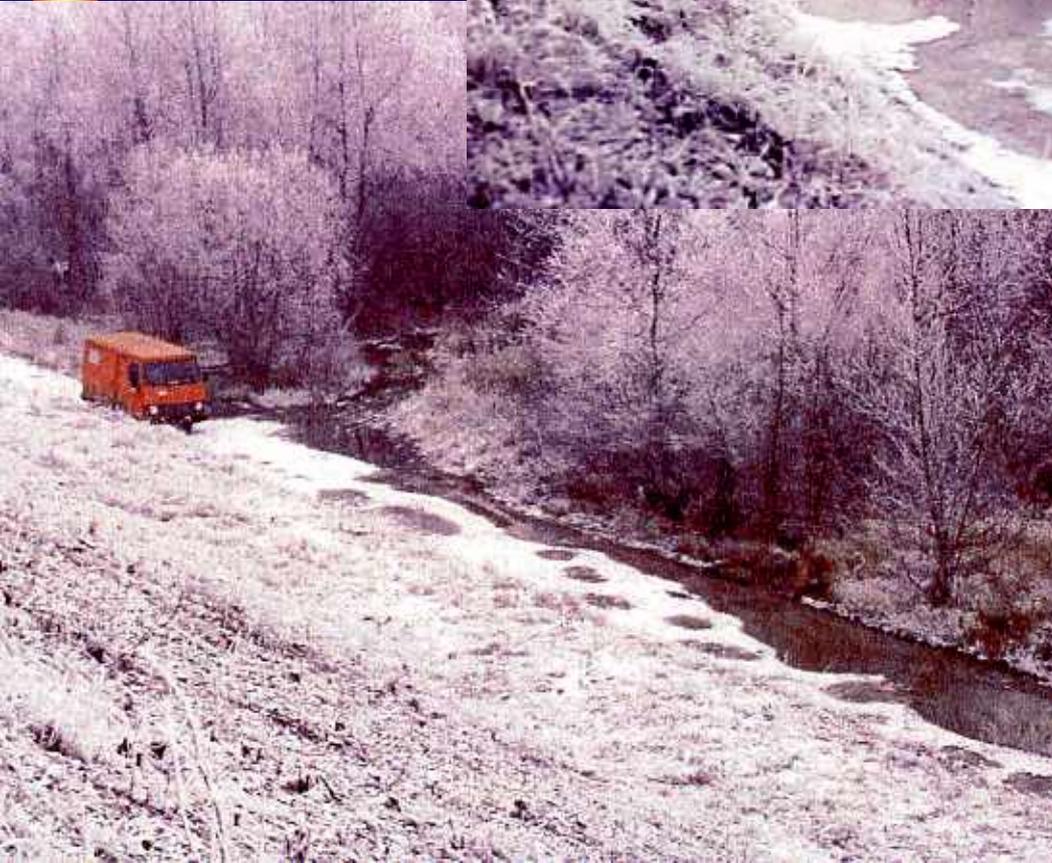
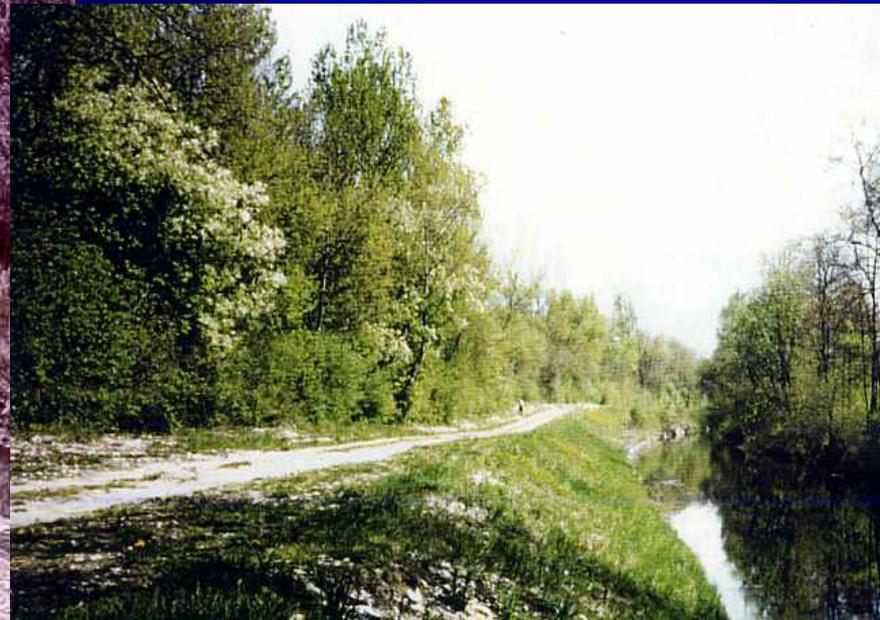
# Embankment or foundation with unstable soil

4 - Suffusion

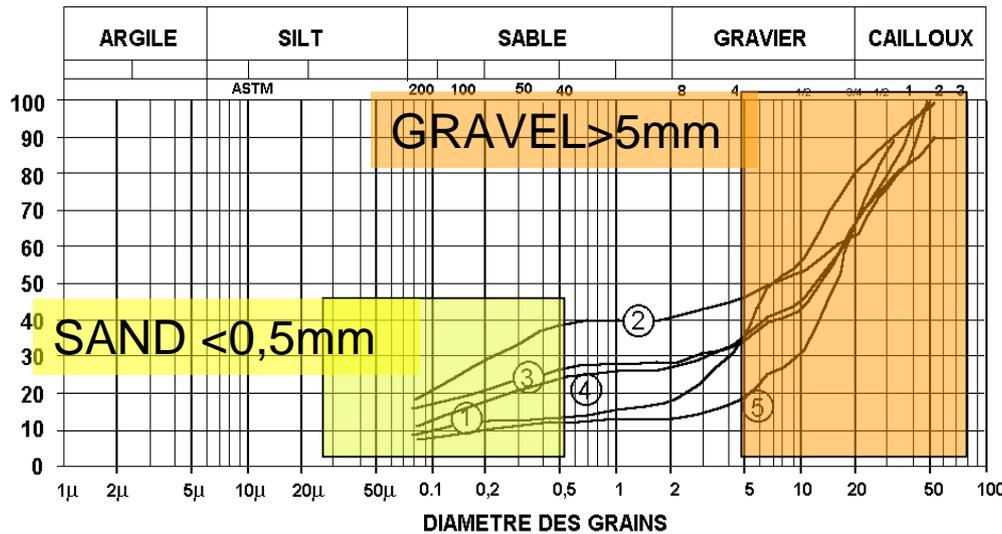
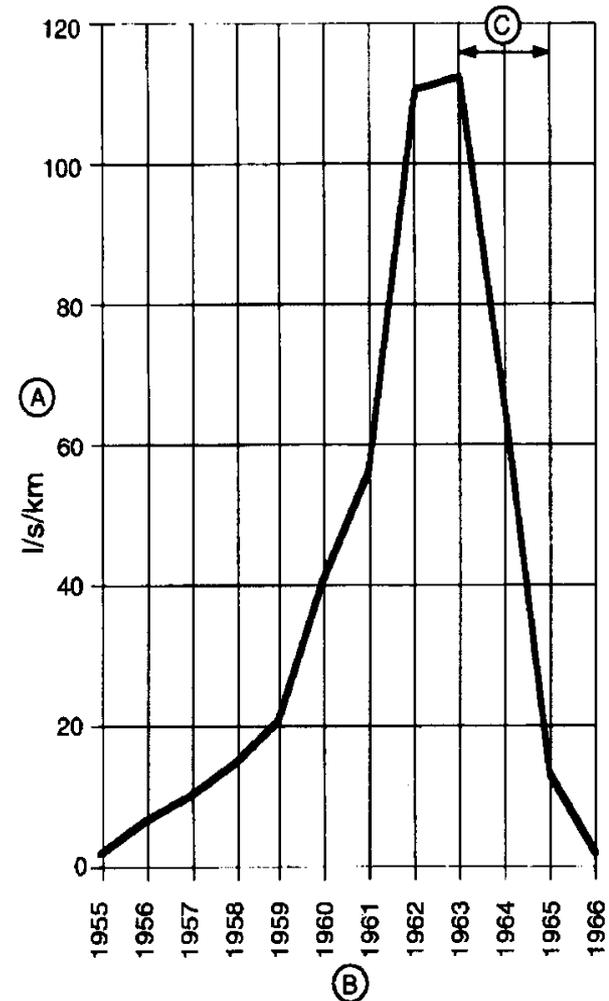
## 4 - Suffusion

$$V < \# 0,5 \text{ cm/s ?}$$

Digue de Cusset - Évolution des fuites au Pk 14.6  
Cusset bank - Point 14.6 leakage variation

- m (A) Specific leakage (l/s/km)
- (B) Date
- (C) Grouting

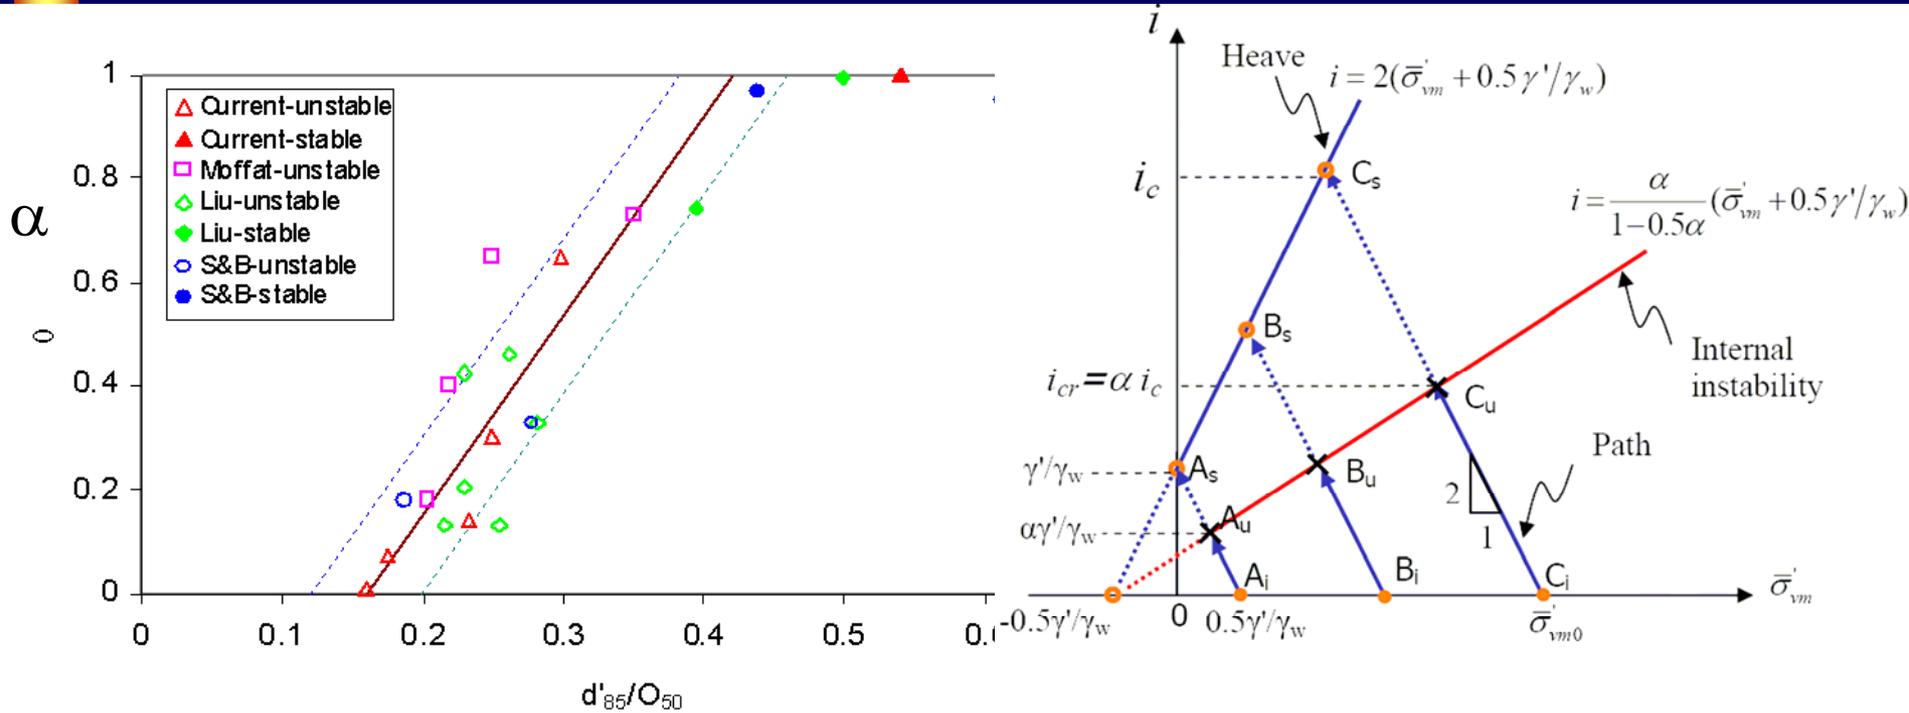
## Initiation de la suffusion

## Geometric et hydromecanic criteria from Fannin (2008)

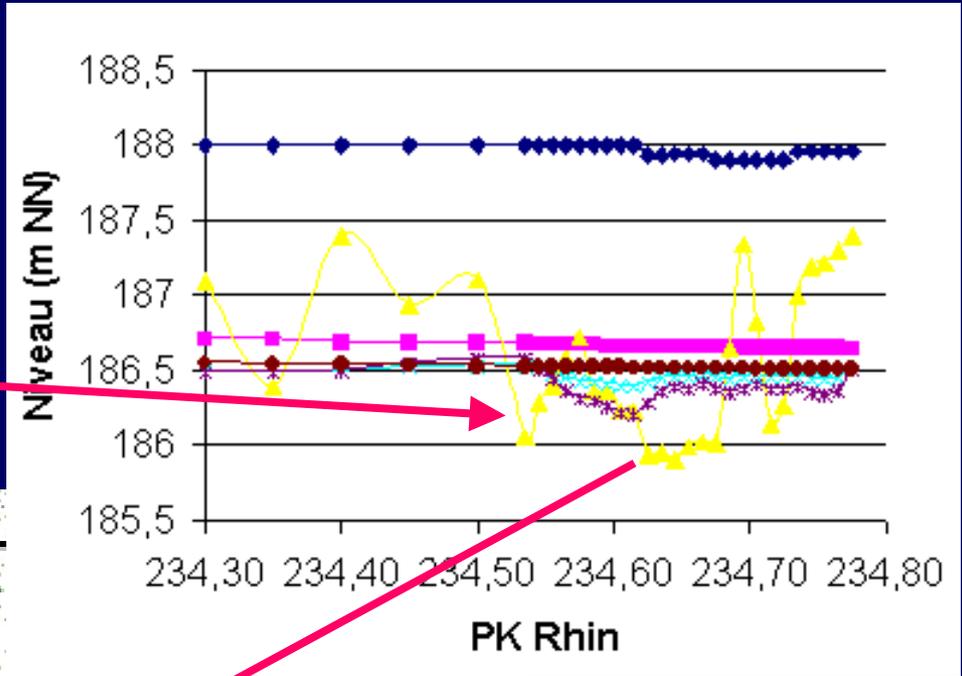
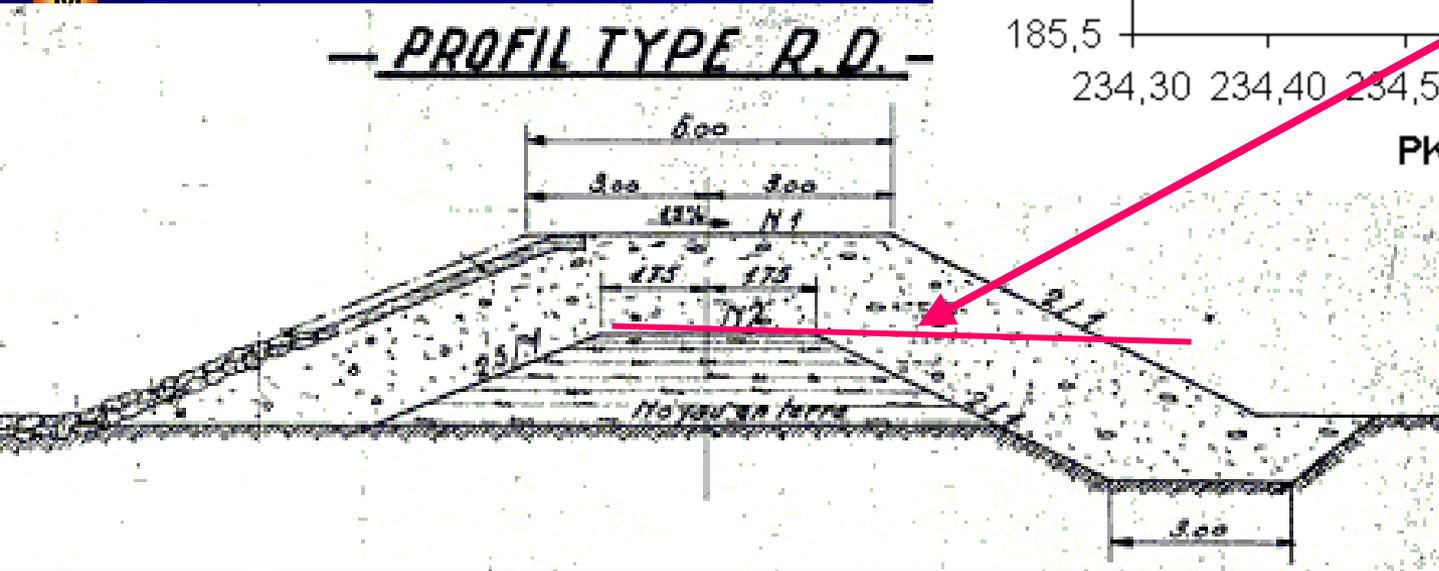
# Contact erosion on Rhine river dike

Crest elevation after maintenance

Core elevation

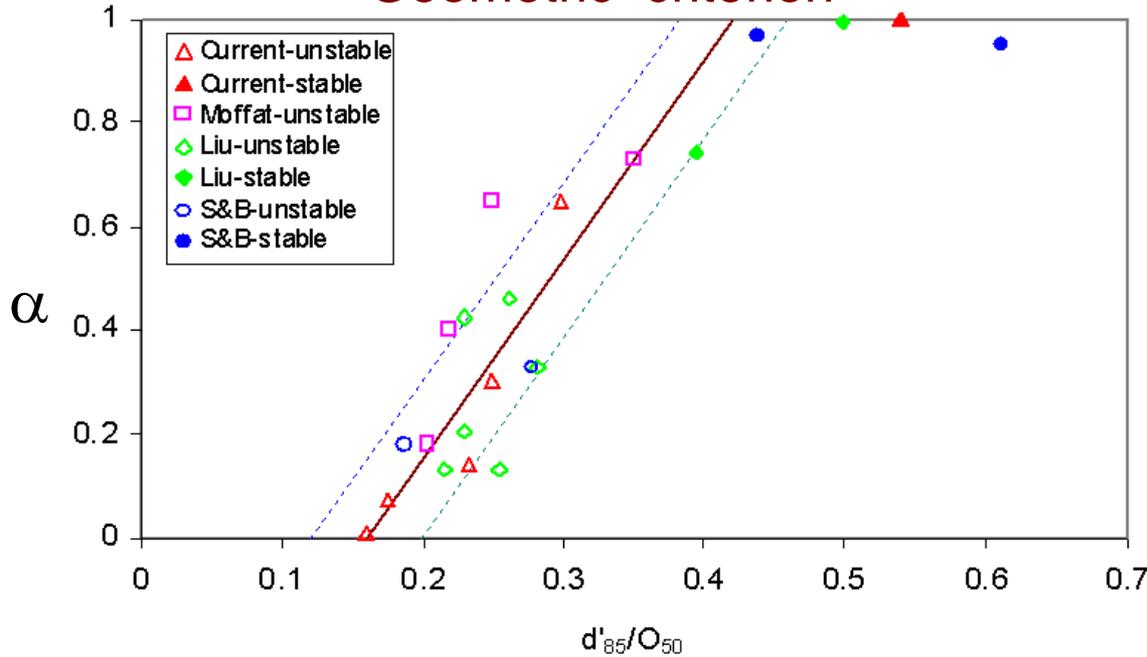
### Geometric criterion

## Double criteria proposed by Fannin (2008)

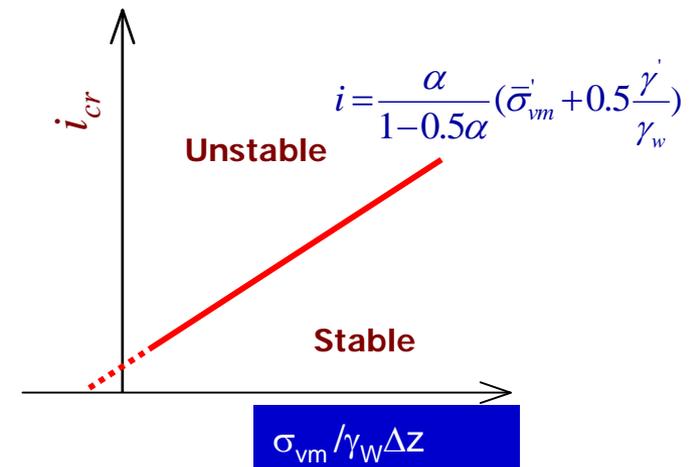
### Hydromechanical criterion

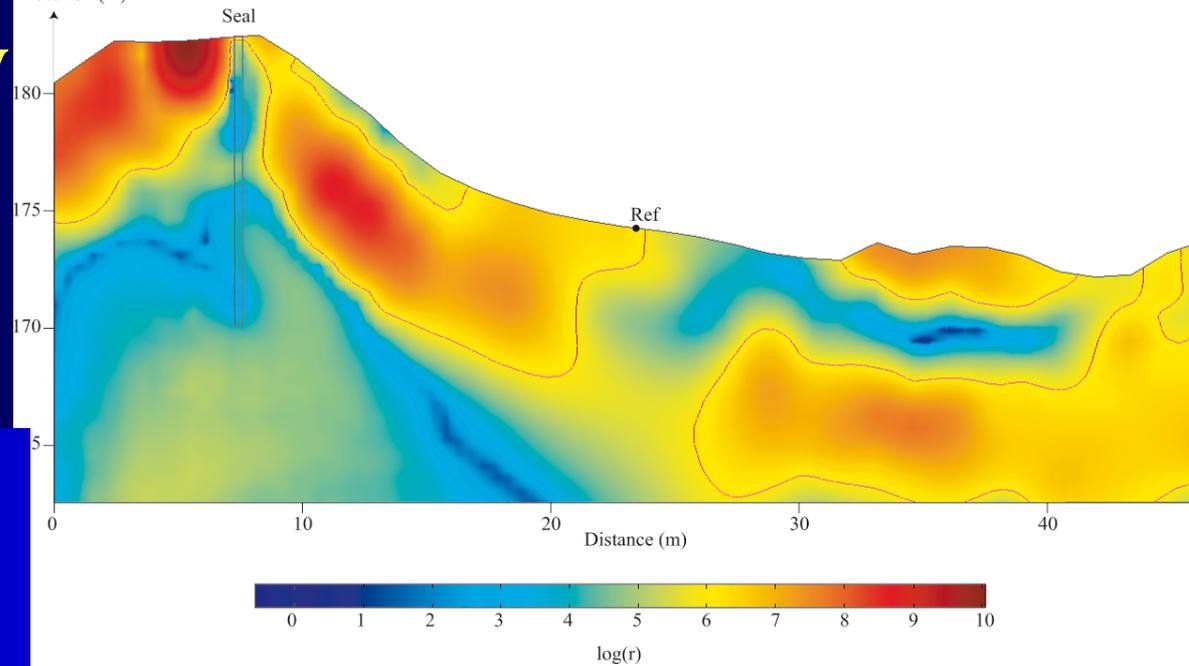
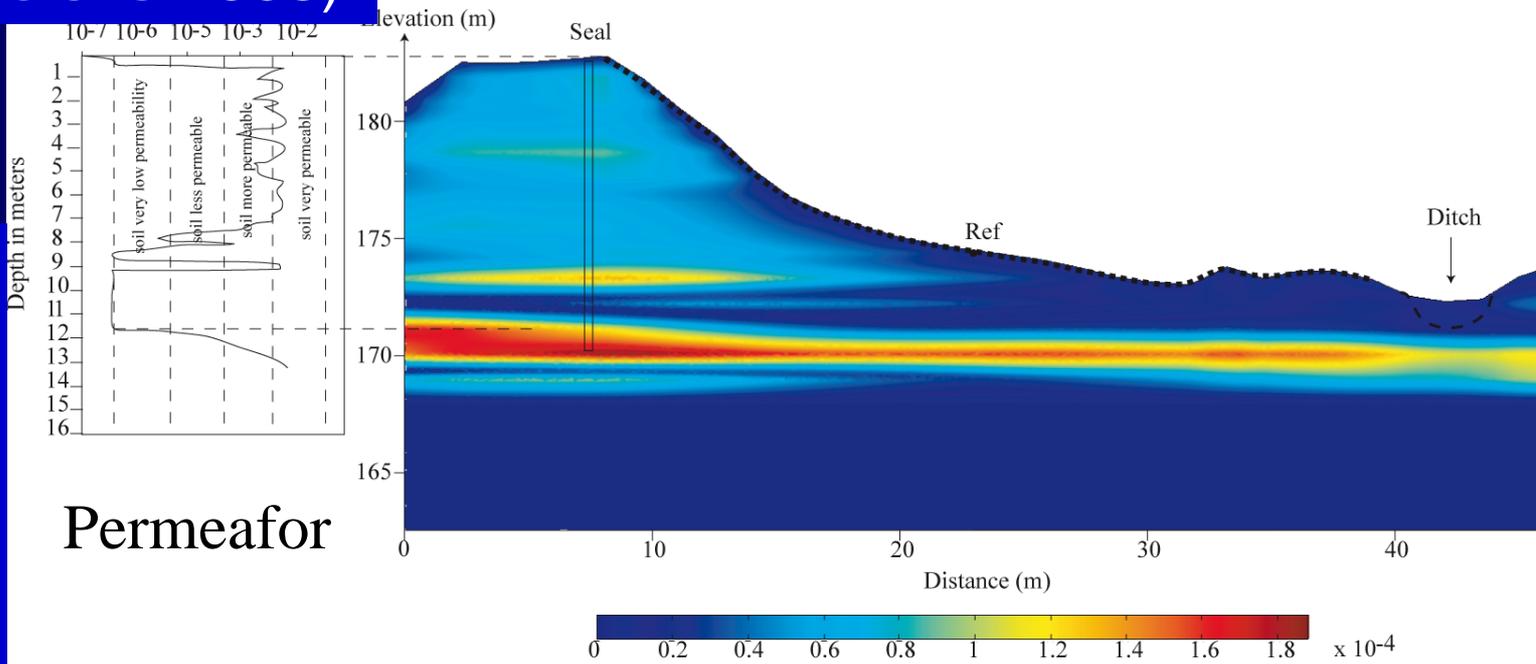
# Detection by SP in soft foundation

Resistivity

Tomography

Water leaks from External current density

Permeability

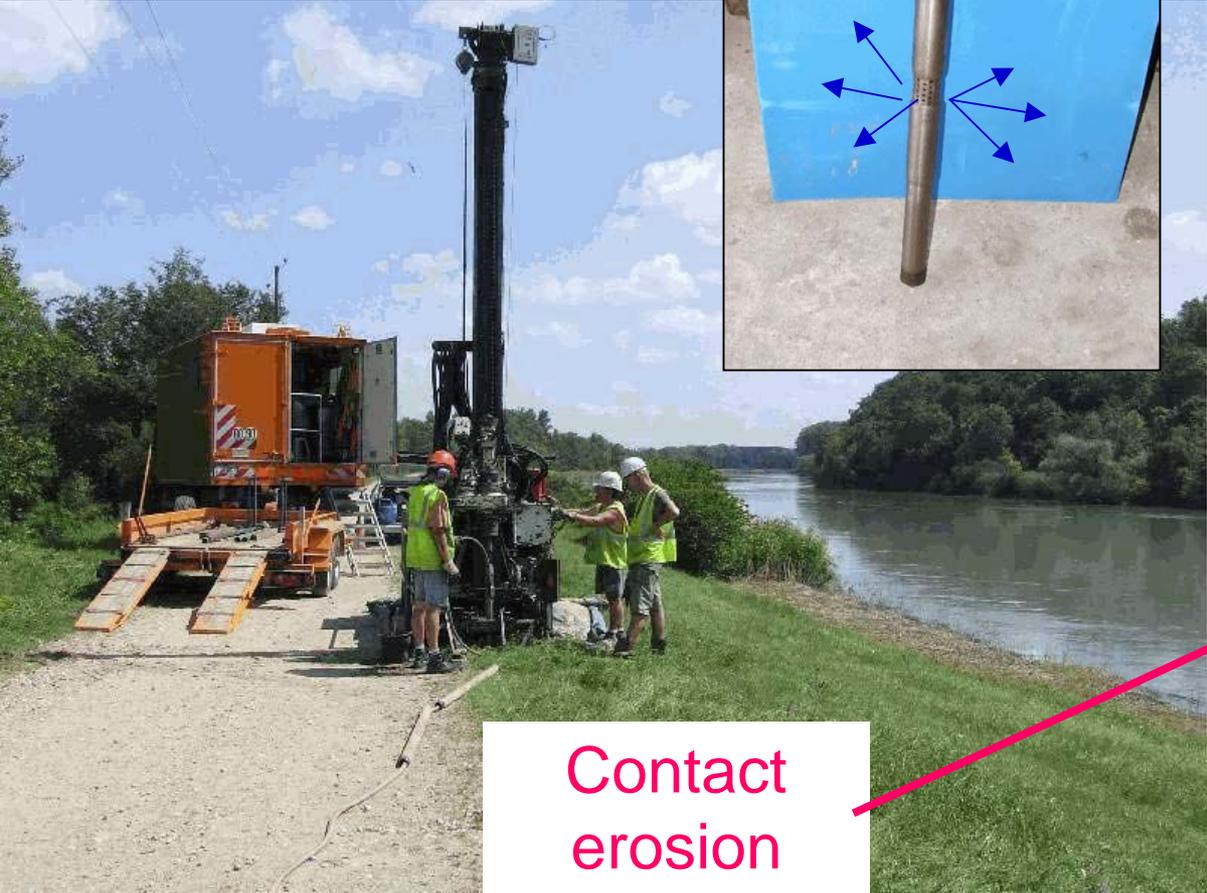
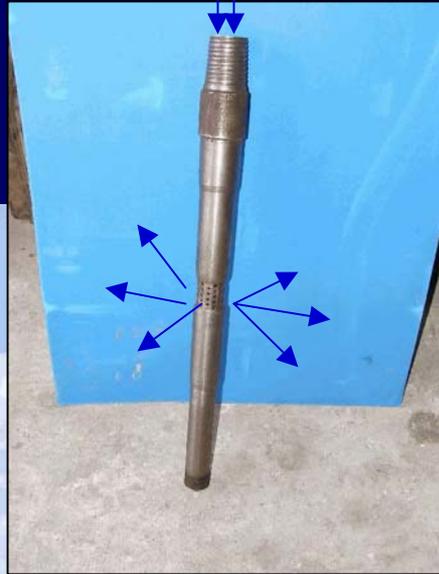
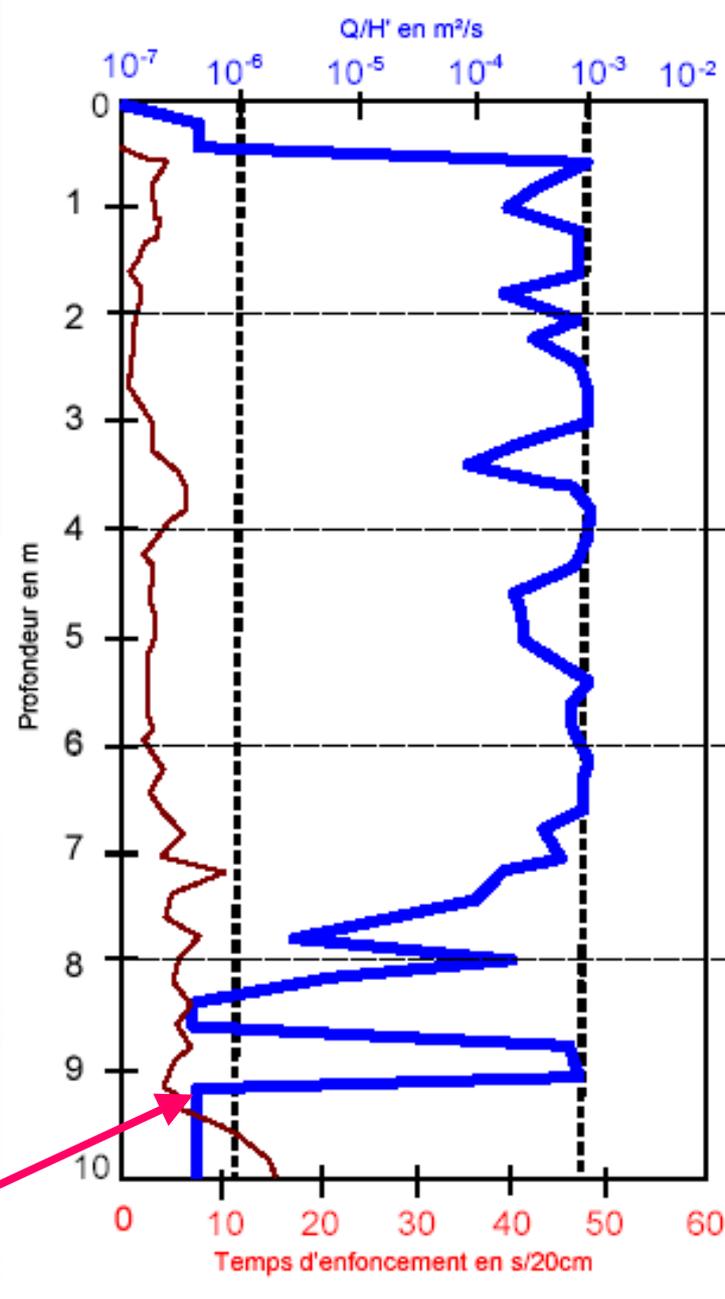
# Detection of contact erosion with Permeafor

Contact erosion

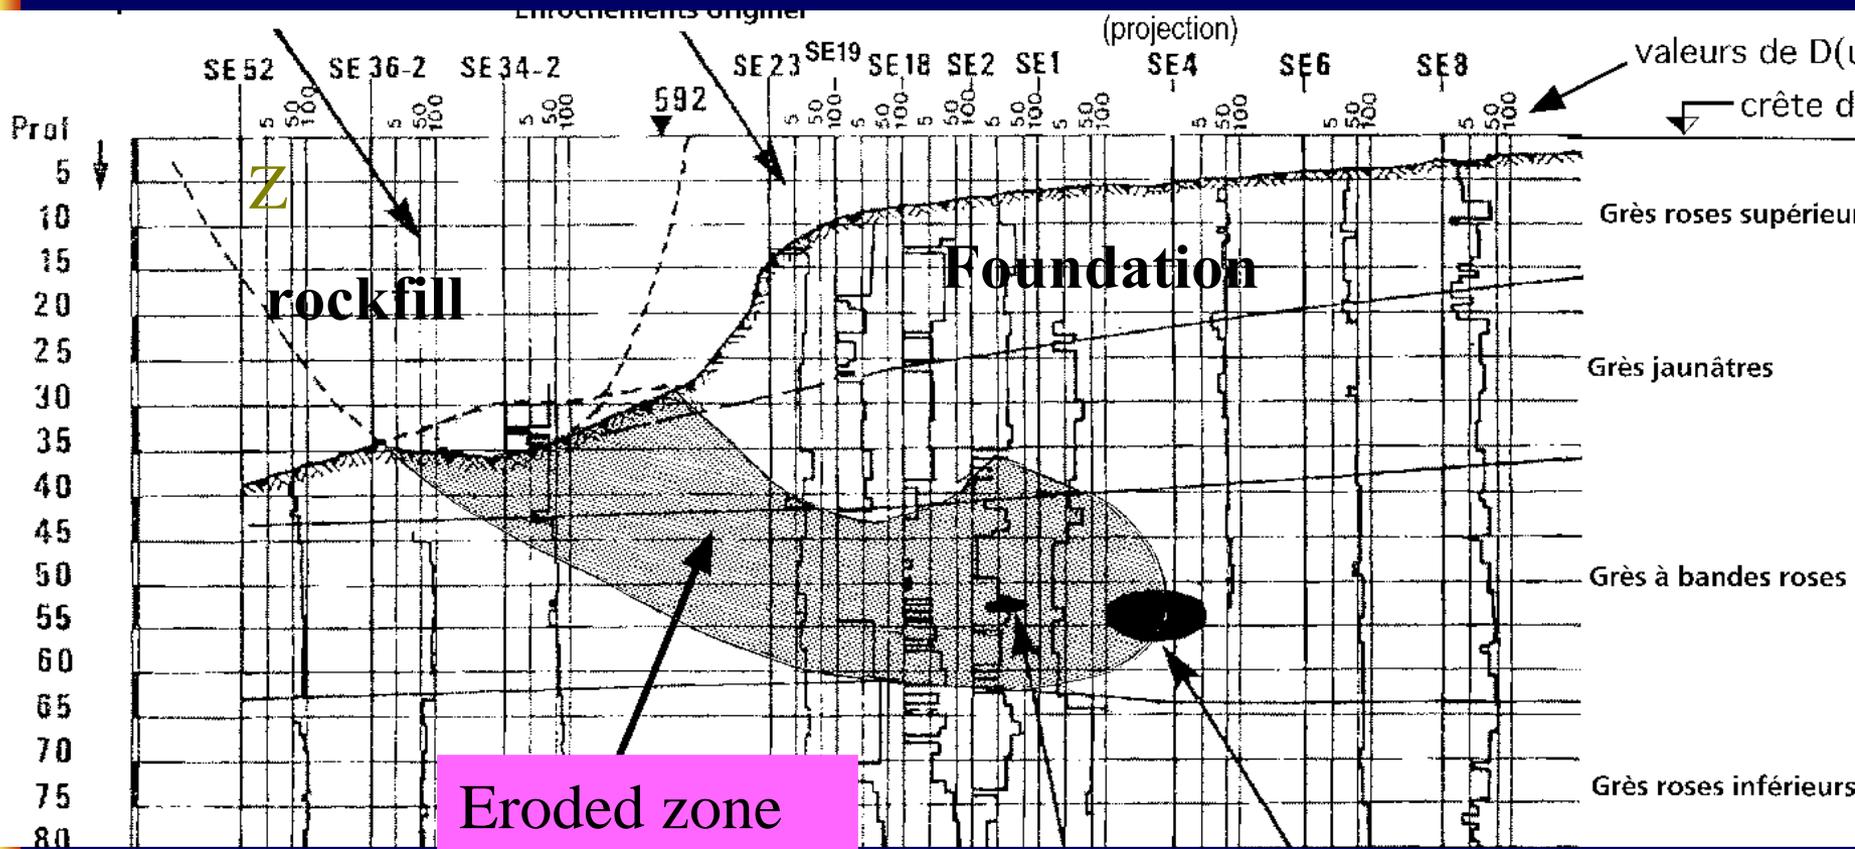
# Detection at ITIYURO dam

Drilling parameter recording on weak sandstones which suffered internal erosion show very low hardness values :  $DUR < 20$ .

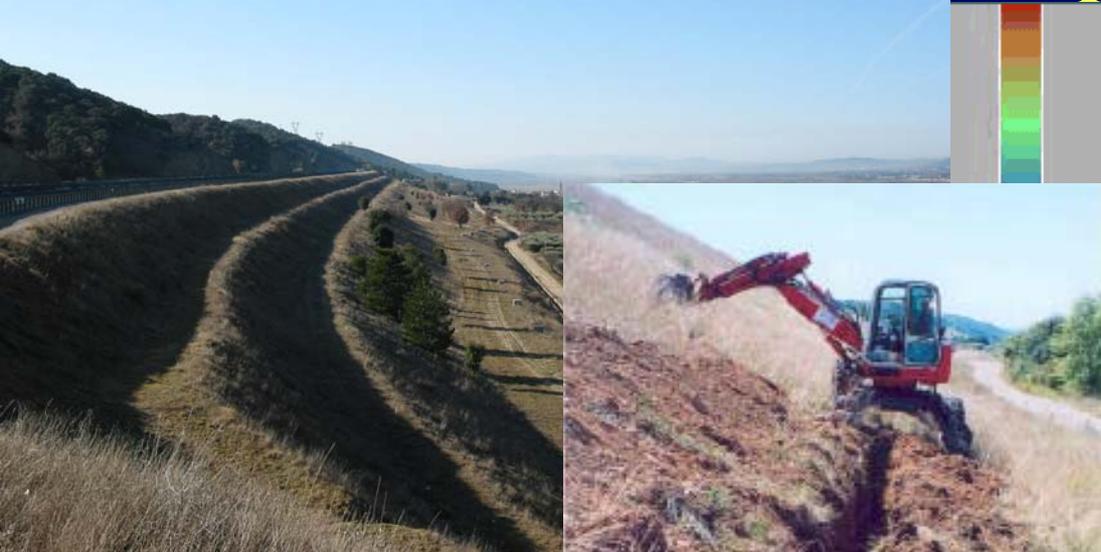
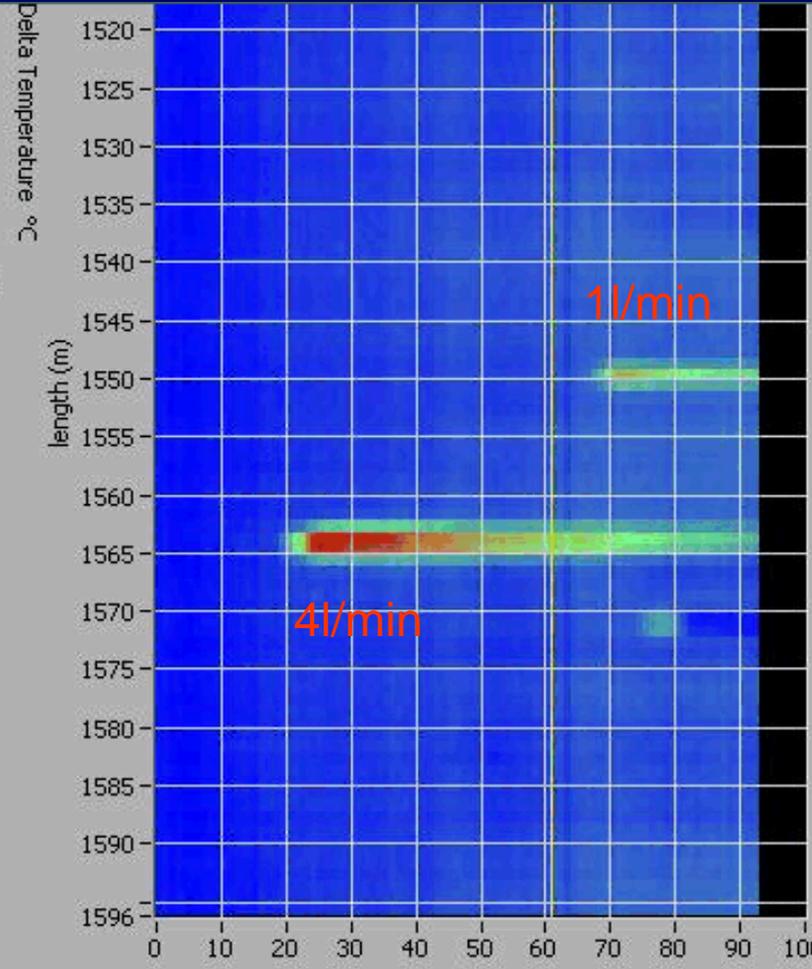
## Oraison canal 2005

## Optic Fiber : passive method

Leakage  
detection : 4  
& 1 l/min?

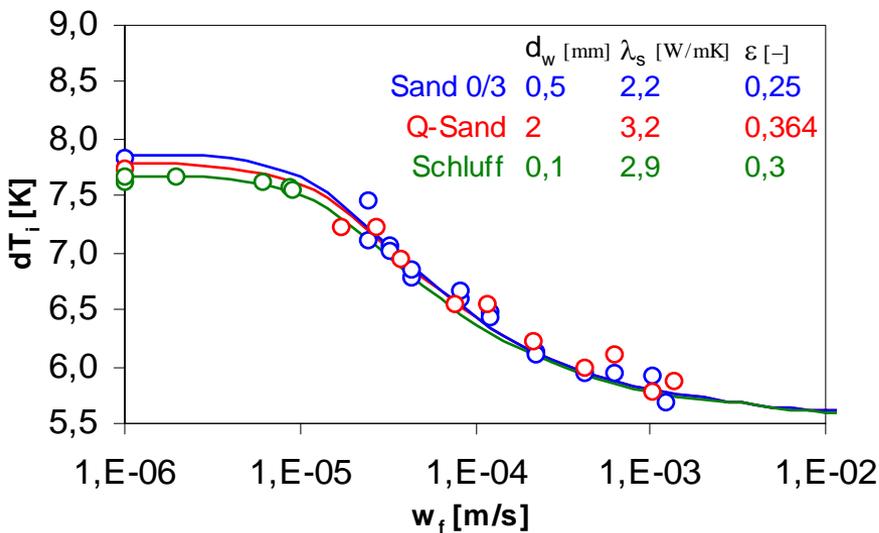
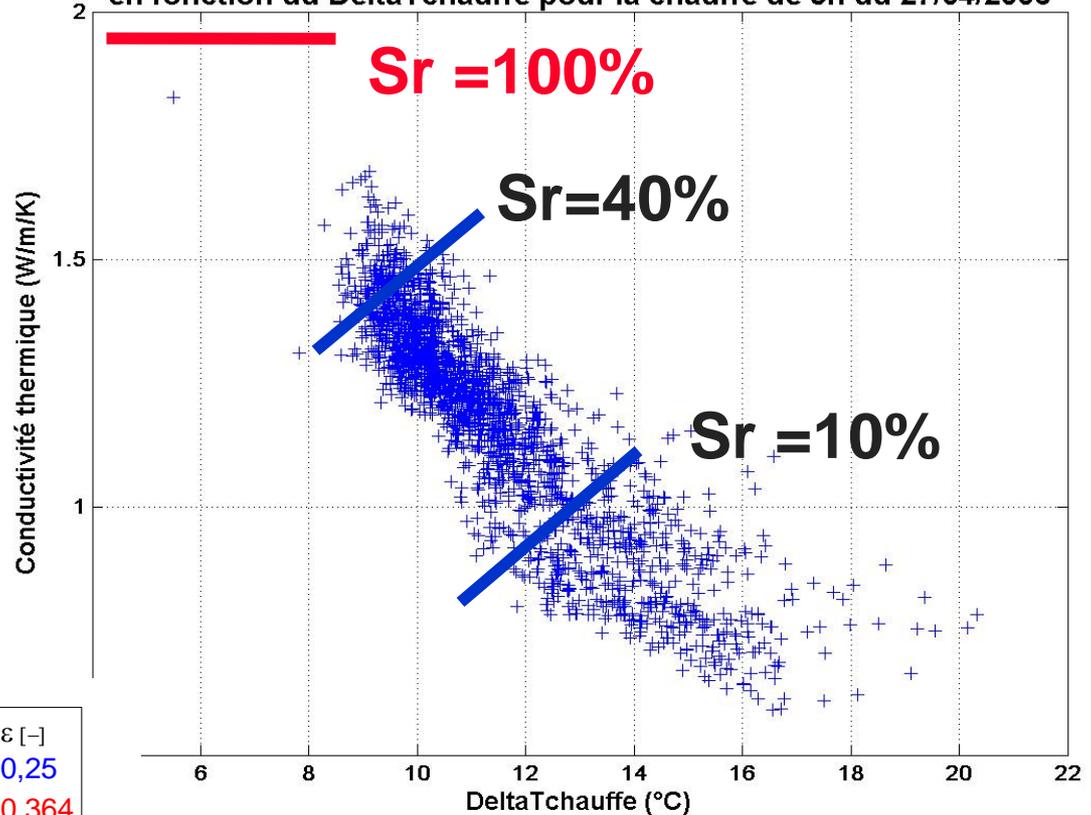
# Flow velocity (TUM 2006)

Visualisation 1D - Graphique de la conductivité thermique en fonction du DeltaTchauffe pour la chauffe de 5h du 27/04/2006

active method:

No leak at Oraison :  
(EDF 2006)

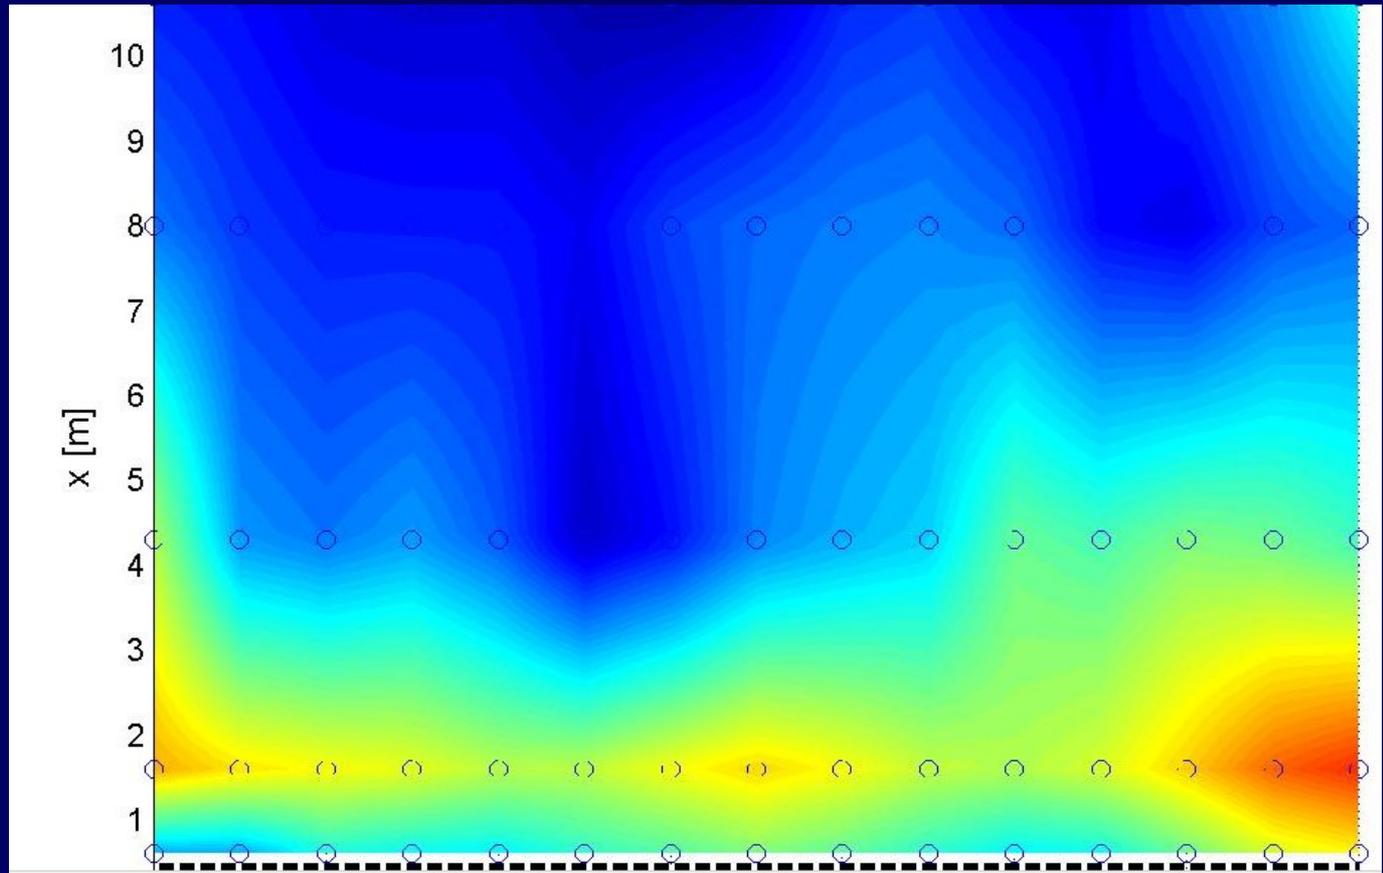
# IJKDIJK Test 2

Detection  
by  
température  
19 october  
2009  
14h58  
24H after  
the start

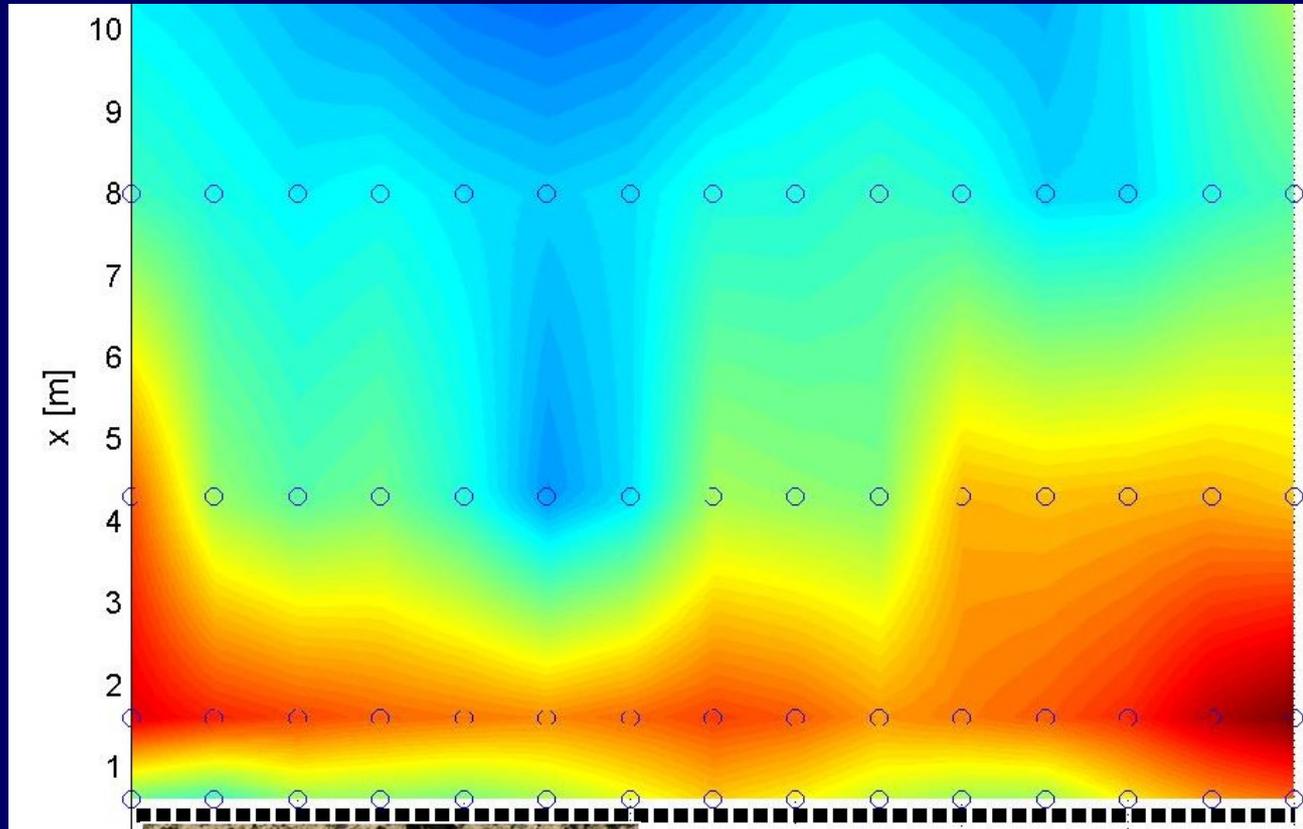
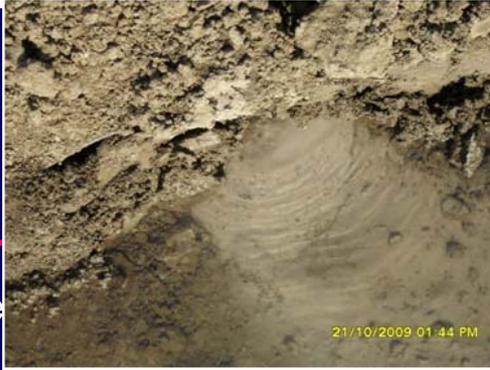
# IJKDIJK Test 2

Detection  
by  
température  
20 october  
2009  
11h58

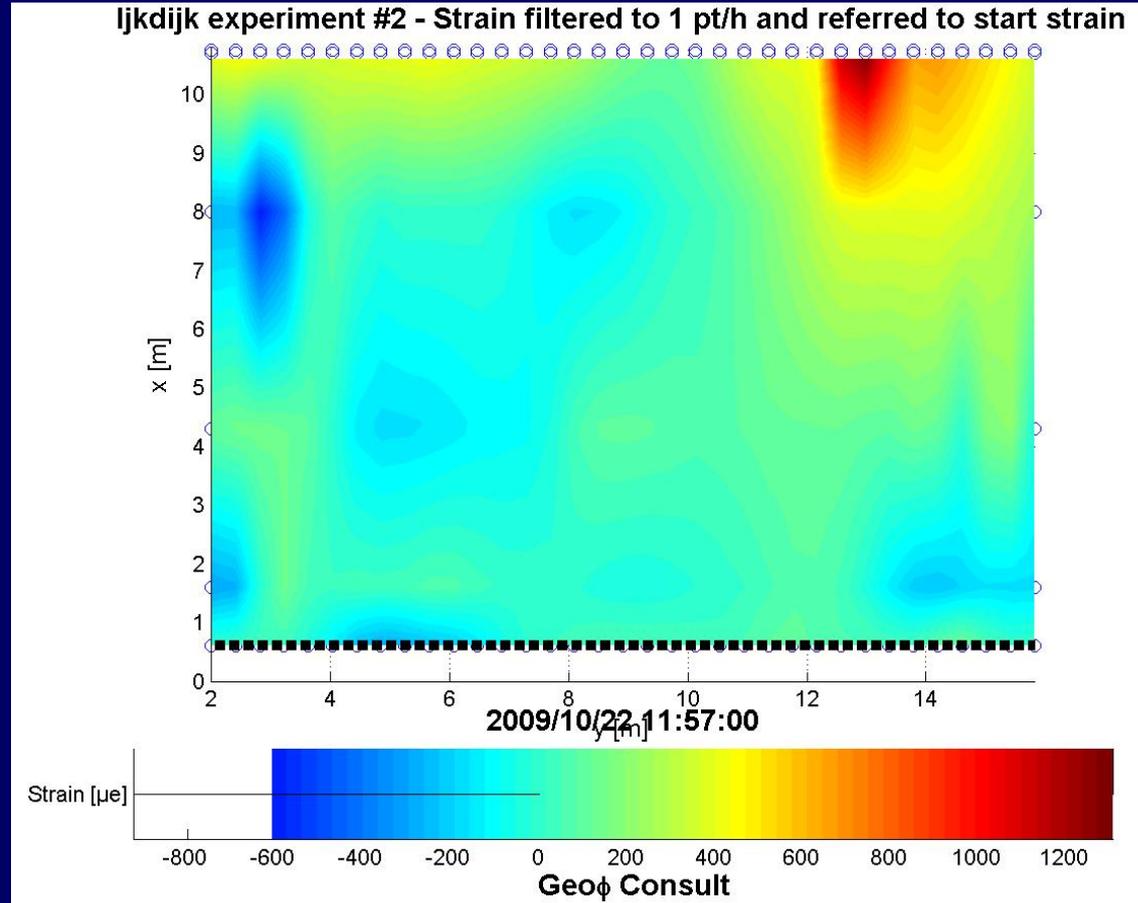
# IJKDIJK Test 2

Erosion  
Détection  
with strain  
measurements  
22 October  
2009  
11h57
